L. Kuiper en W. Hesterman

Restauratieverslag van Rembrandts Nachtwacht

Report on the Restoration of Rembrandt's Night Watch

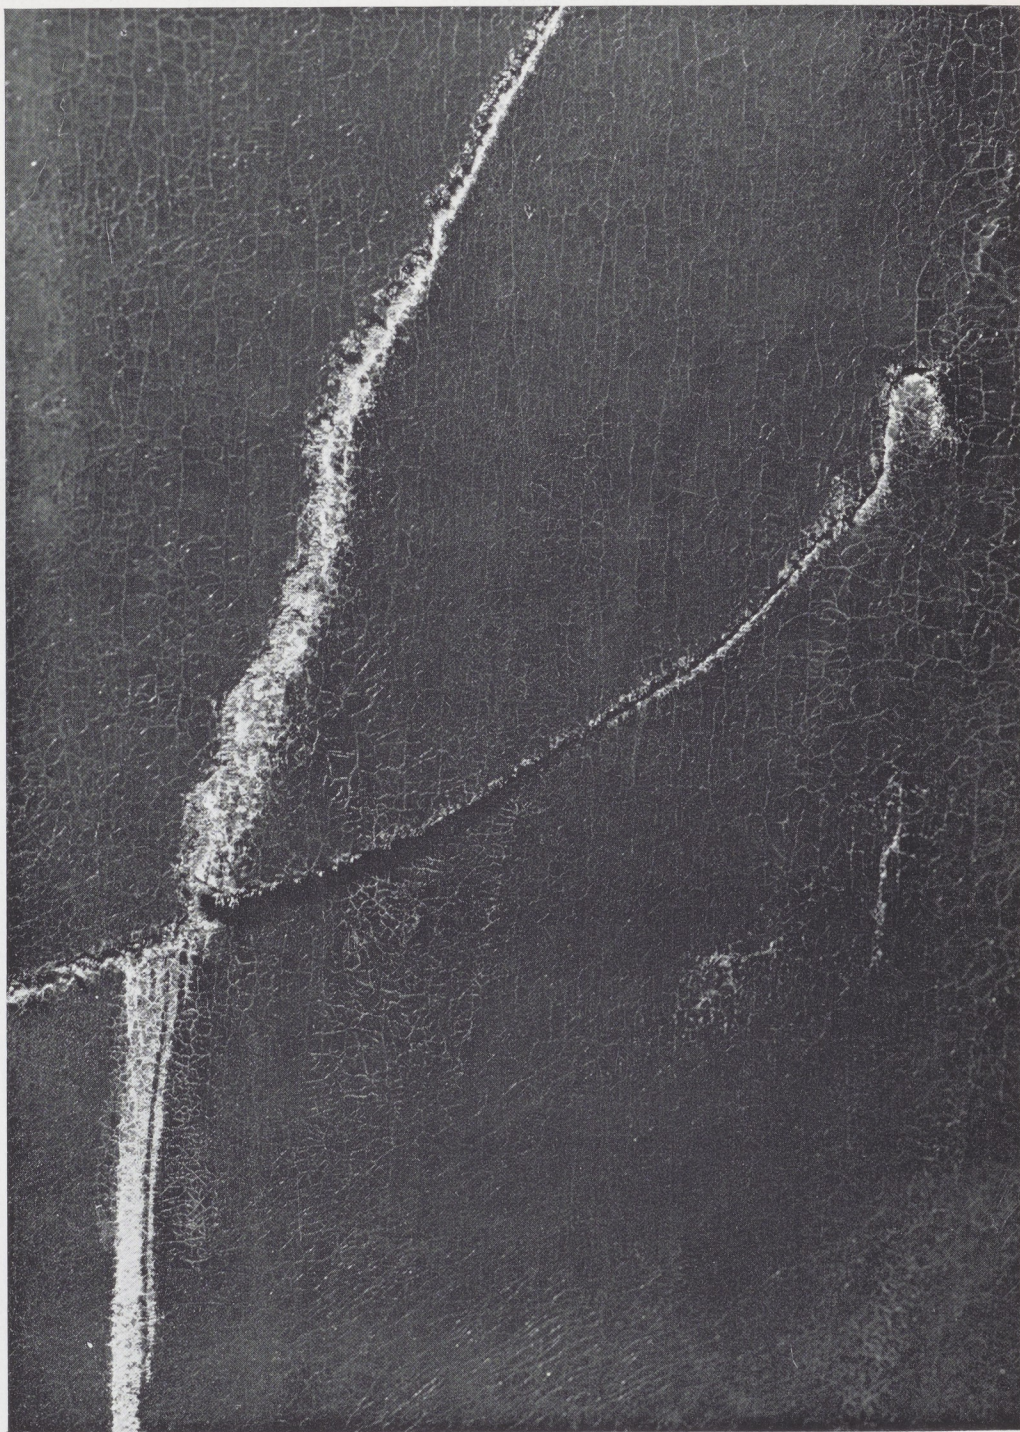
The report made on 14 September 1975 immediately after the painting was damaged reads as follows: The painting was cut 12 times with a knife, the cuts varying in length from 100 to 39 cm (*see pag. 5, Fig. 1*). The knife made a number of large scratches in the varnish and in some places it went through the paint layer and the original canvas, which has become frayed, but was deflected by the relining canvas. Elsewhere it went right through the relining canvas as well. In the cuts and along their edges there is considerable paint loss. From the nature of the damage it can be deduced (1) that the stabs and cuts were inflicted with great force and (2) that, probably as a result of the force and speed of the blows, the blade of the knife was bent slightly to the left, some of the cuts (notably those on the right just above the dog) being pressed obliquely inwards and all the cut edges being frayed (*Fig. 1*). In the area of Banning Cocq's breeches a triangular piece (28 × 6 cm) of the original painted

Afb. 1. De schuine sneden boven de hond, waardoor een stuk doek naar voren werd gewrongen.

Fig. 1. The slanting cuts above the dog, which had wrenched a piece of canvas forwards.

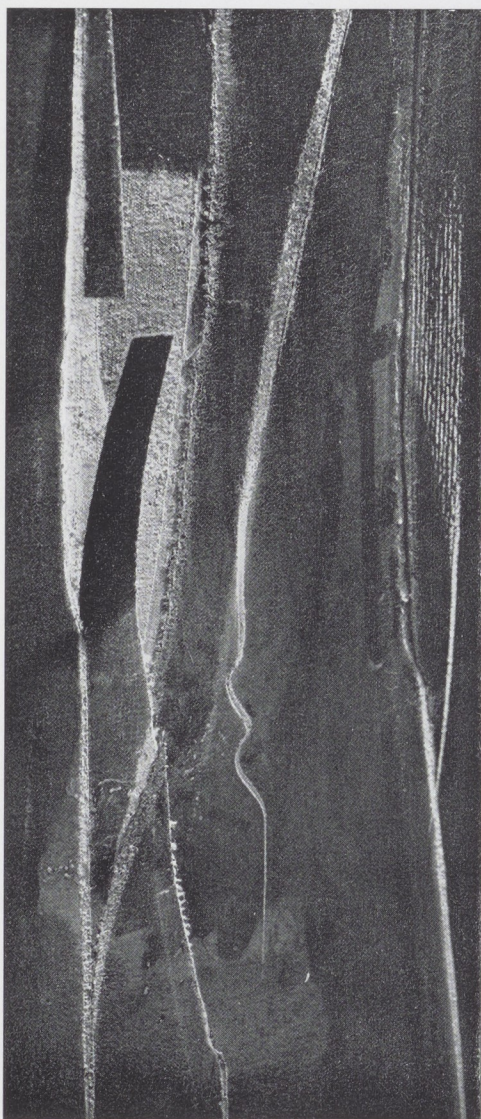
Afb. 2. Voorkant met de loshangende repen doek naast de plek, waar een driehoekig stuk uit het schilderij is gesneden. Door het gat ziet men het doubleerdoek.

Fig. 2. The front of the painting showing the strips breaking away beside the place where a triangular piece had been cut out of the painting. The relining canvas can be seen through the hole.

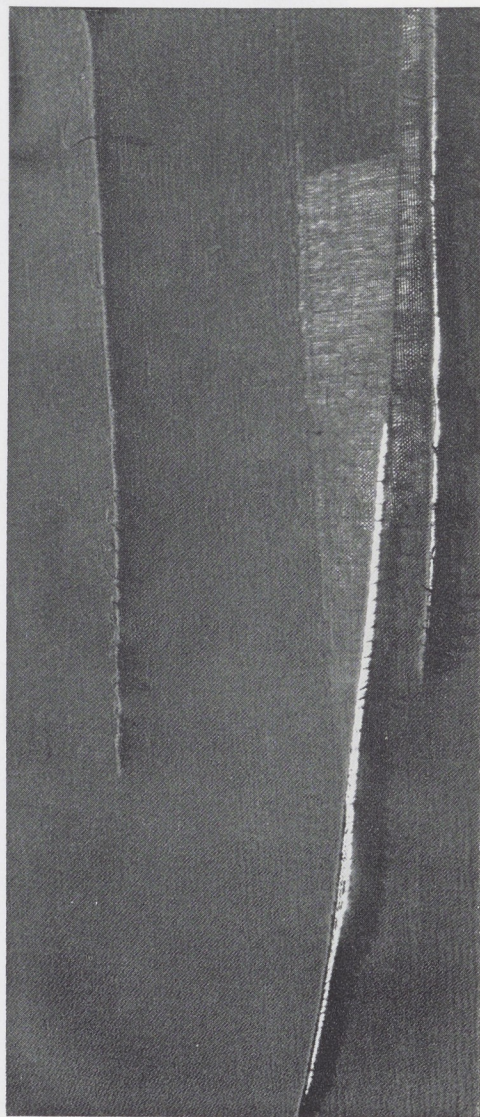
Afb. 3. De beschadiging van afb. 2 gezien aan de achterkant.

Fig. 3. The damage in Fig. 2 seen from the back.

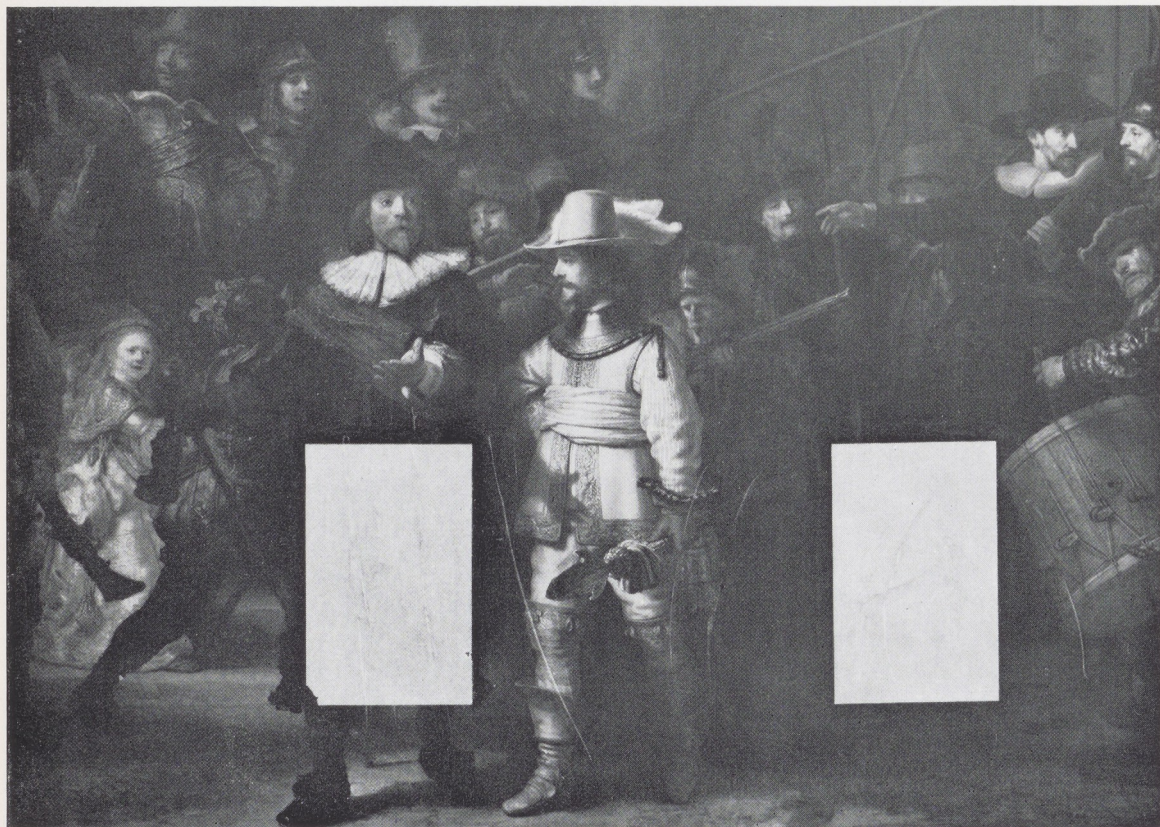
Afb. 4. De ergst beschadigde plaatsen beplakt met Japans papier.

Fig. 4. The most badly damaged areas pasted over with mulberry paper.

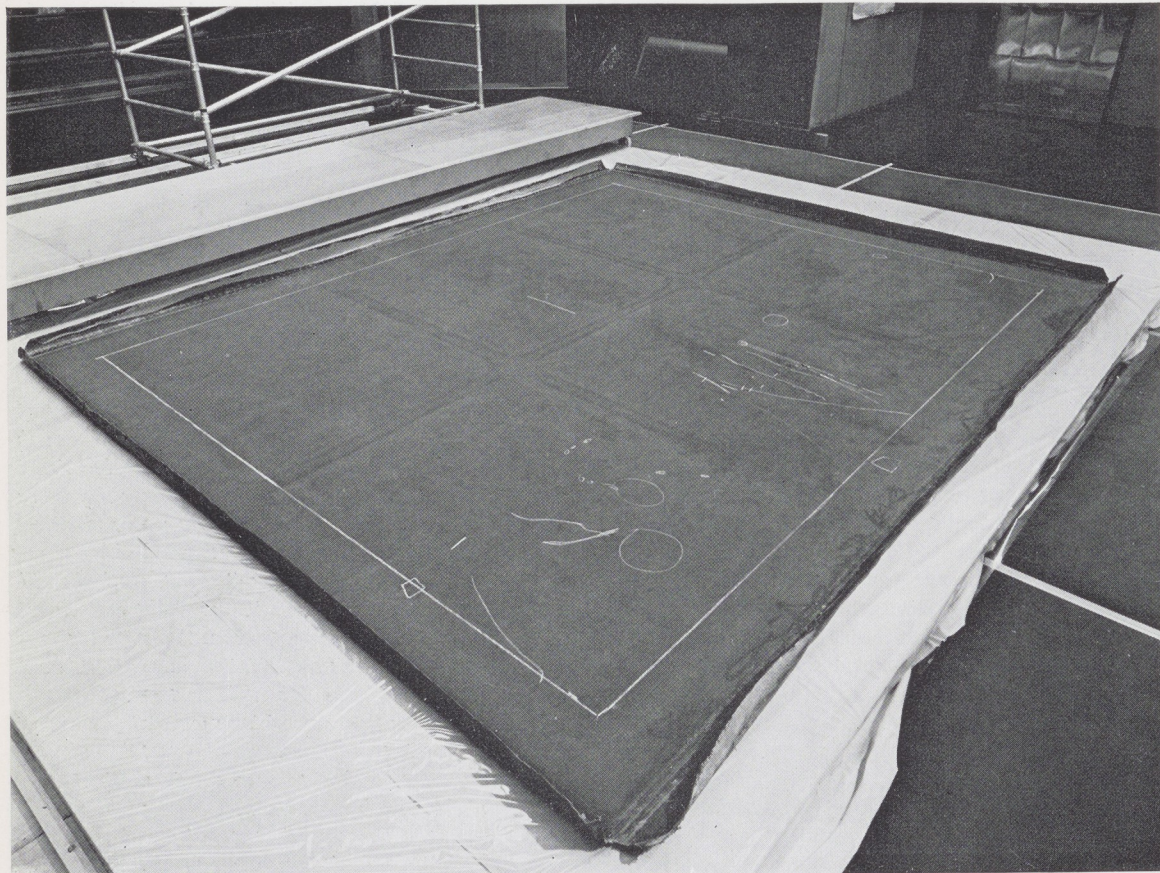
Afb. 5. Het van het spieraam gehaalde schilderij liggend op de met vilt en melinex beklede werkvloer. Links boven de verrijdbare werkbrug. Op het oude doubleerdoek zijn de beschadigingen met krijt aangegeven. De rechthoekige krijtlijn markeert de voorlopig te handhaven randen van het doubleerdoek.

Fig. 5. The painting, taken off the stretcher, lying face downwards on the felt and Melinex covered work floor, with the movable work bridge top left. The damage is marked with chalk on the old relining canvas, while the rectangular chalk line marks the borders of relining canvas that were temporarily to be retained.

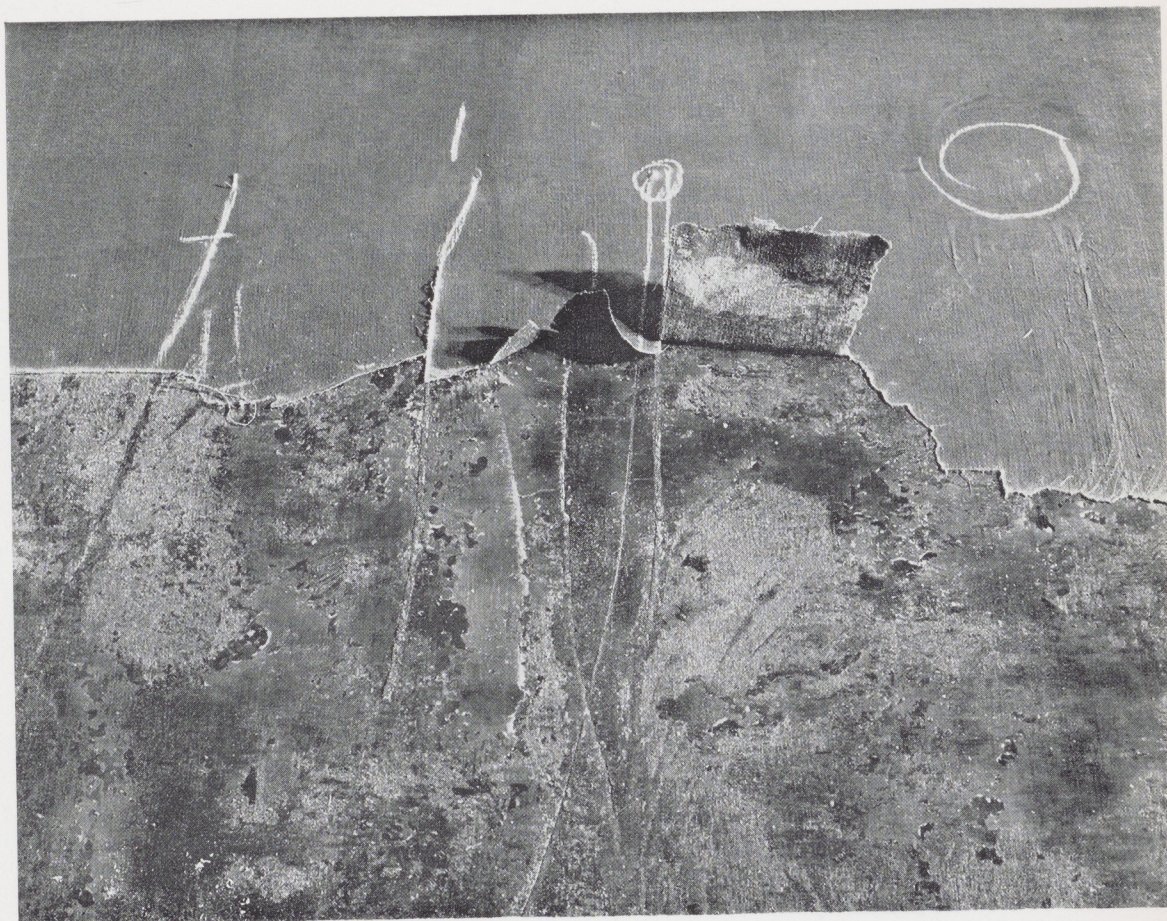
Afb. 6. Achterkant met het doubleerdoek ten dele verwijderd.

Fig. 6. The back of the painting with the relining canvas partly removed.

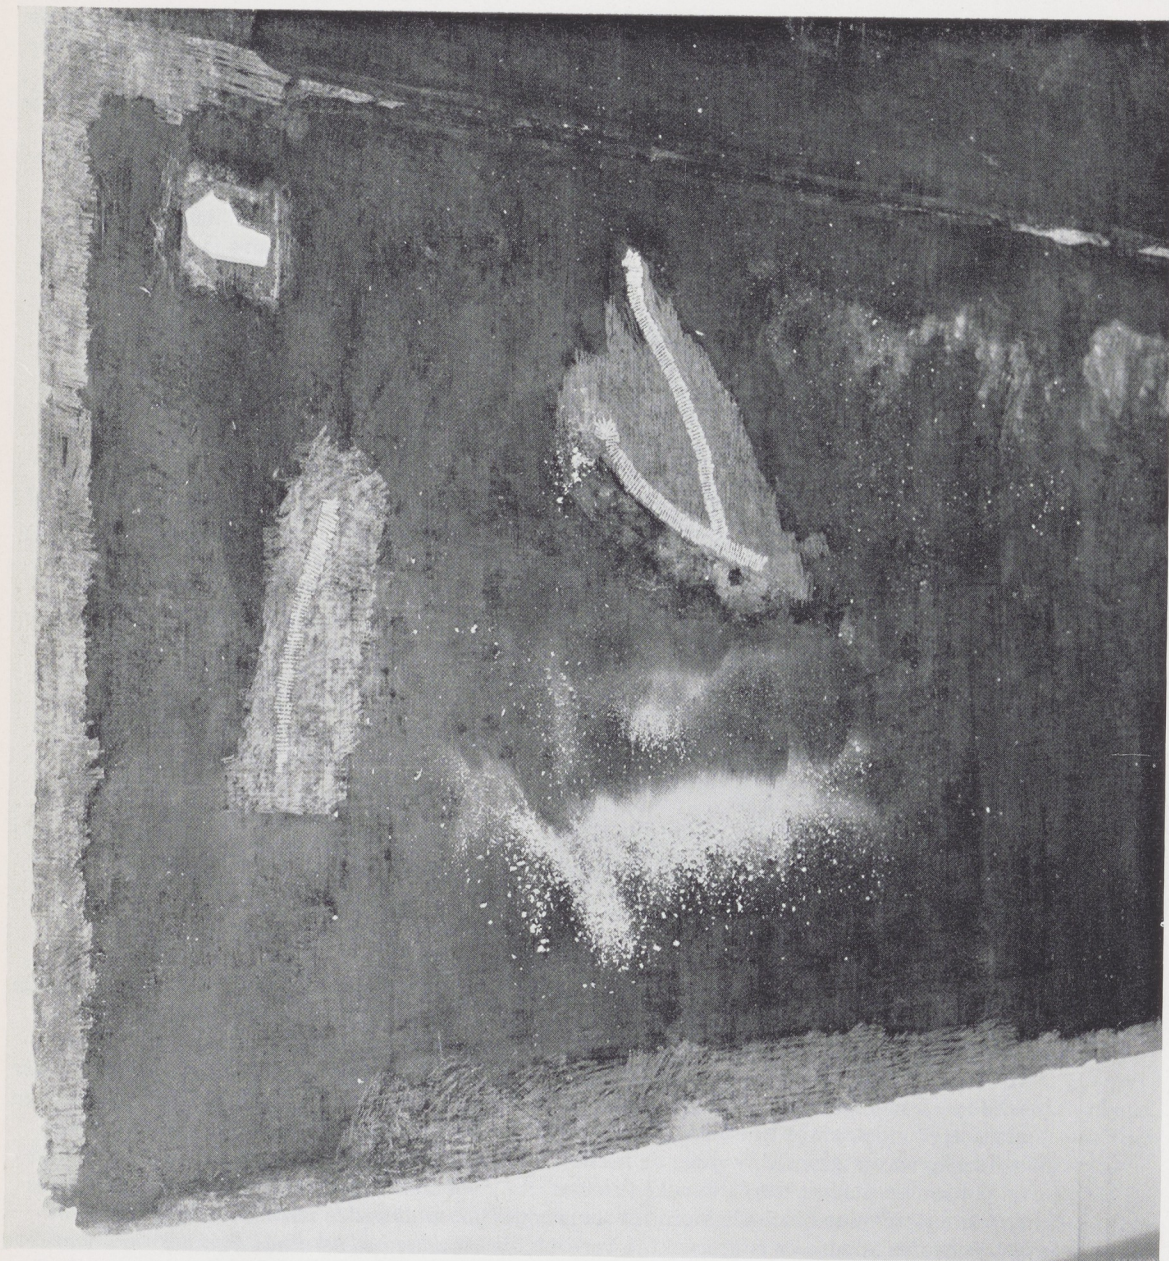
Afb. 8. De gehechte sneden, breuken en oude beschadigingen. Links bovenaan het gat in de trommel. Bovenaan de onderste originele doeknaad.

Fig. 8. The mended cuts, breaks and old damage, with the hole in the drum top left and above it the lower seam in the original canvas.

On the basis of the results of these seven tests it was decided to remove the superfluous remains of wax-resin adhesive with xylene, except at those places where the xylene might penetrate the paint layer, which would have to be scraped. After this treatment had been carried out, the cuts, breaks and various other old areas of damage were mended with linen fibres dipped in thinned Araldite. Once the Araldite had hardened the joins were shaved as flat as possible with a knife and tapered off at the ends (Figs. 7 and 8).

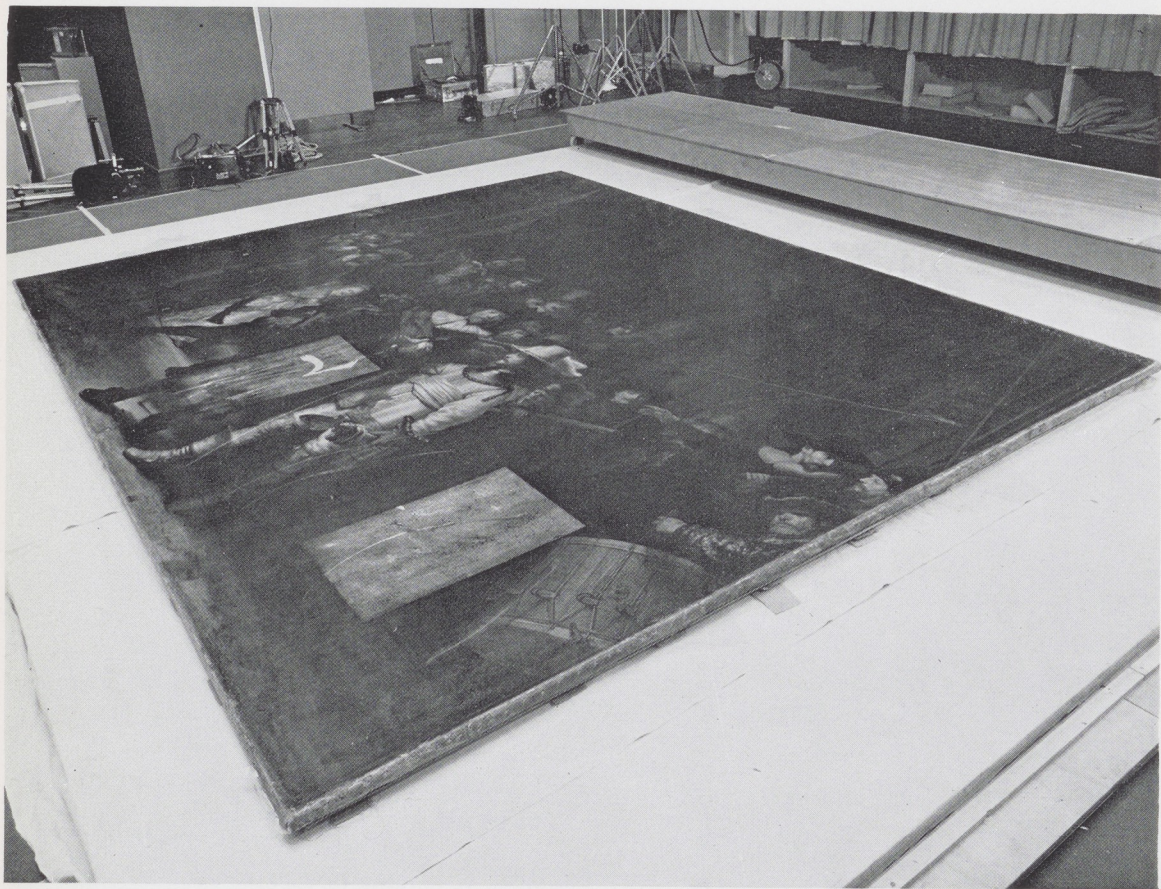
Afb. 10. Na verwijdering van de vellen Japans papier blijken de gehechte beschadigingen volkomen vlak te liggen.

Fig. 10. After the sheets of mulberry paper had been removed, the mended damage proved to be lying perfectly flat.

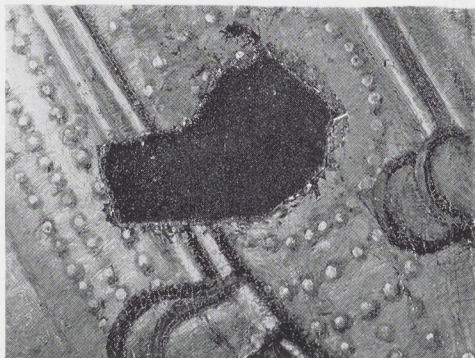
Fig. 11. The old hole in the drum. The old insertion has been replaced by a new one that still has to be painted.

Only the insertions in the bottom edge of the painting and the drum required repainting, as opposed to inpainting, the insertion in Van Ruytenburch's left foot needing to be repainted only in part. In the drum the painting on the insertion that had been removed was followed, since it agreed both with what is to be seen on the Lundens copy at the place in question and with a real drum of the sane type. The recent damage was, of course, rendered invisible. Elsewhere, too, disturbing

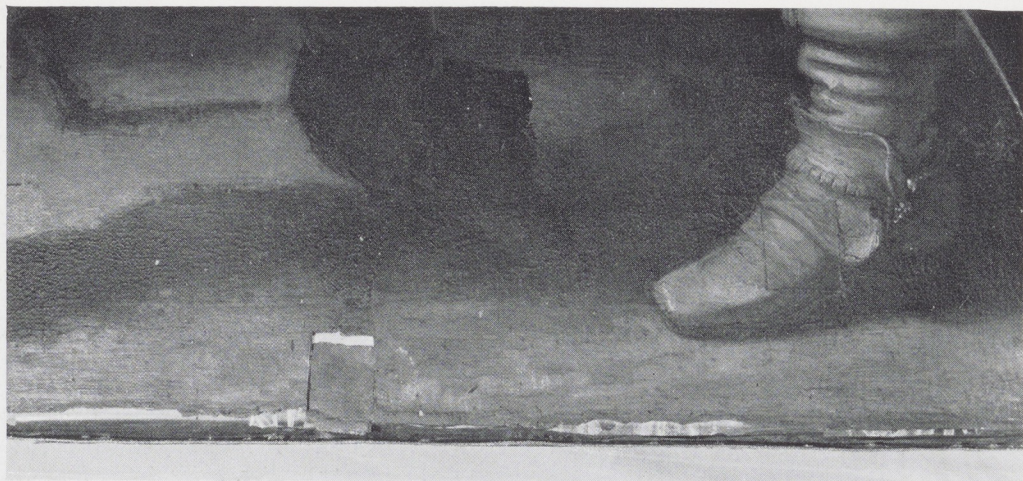
A check was made to see how far old stoppings and insertions applied to the painting in the past needed to be replaced. It was customary long ago in the case of damaged areas of some size simply to cut them out of the painting and to fill up the 'neat' hole thus made with a piece of canvas cut to the required size, which was then painted. The Night Watch has three insertions of this type: in the bottom edge on the right below Banning Cocq's left foot, in Van Ruytenburch's right boot and in the drum. The insertion in the drum had to be replaced, because it appeared from the X-ray photograph that the weave did not run parallel to that of the surrounding original canvas. The insertion was also rather too large (Fig. 11). Of the other two insertions only that in the bottom edge needed replacing on account of its bad positioning and insufficient adhesion (Fig. 12).

Afb. 12. De oude ingezette stukken in de onderrand en de rechter schoen van Van Ruytenburch.

Fig. 12. The old insertions in the bottom edge and Van Ruytenburch's right boot.

Now that the back of the painting was uppermost once more, further work could be done on the insertions and stoppings. The insertion in the bottom edge was replaced. Its shape was traced on to a prepared piece of seventeenth-century canvas, which was cut to size so that it fitted exactly into the hole, into which it was carefully inserted. The same was done with the insertion in the drum. Because one of the air pockets passed over this spot, the painting was peeled of the paper along the whole side of the painting in order to free the canvas. The place was weighted with sandbags and after 12 hours the canvas there was completely flat again. Both the new insertions were bonded to the canvas in the manner de-

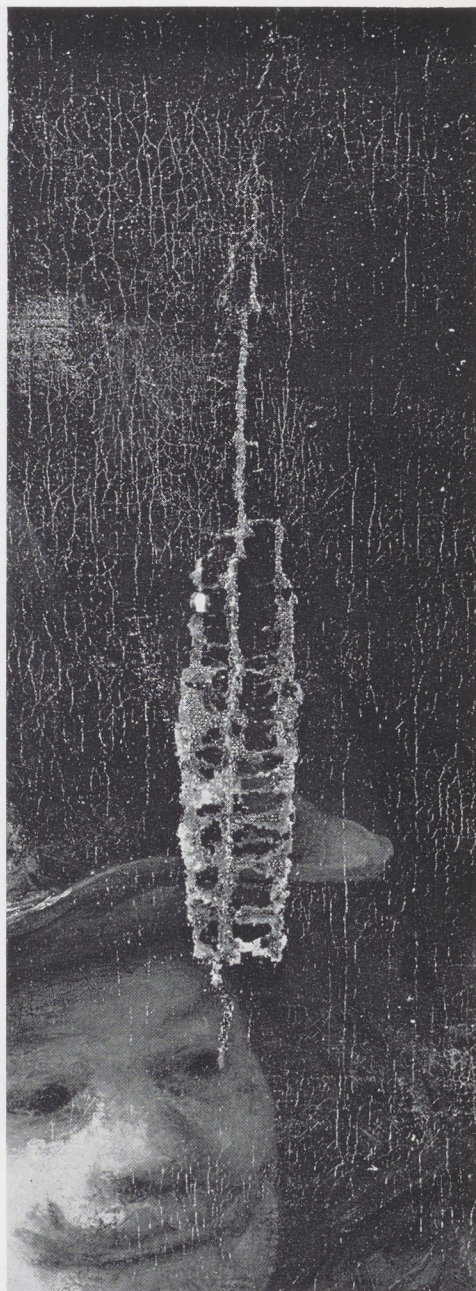
could only be laid down via the back of the painting. The second test was done beside the tall hat of the militiaman immediately above Banning Cocq, where a large area of damage (25×4 cm) had been repainted in the past. After the removal of the varnish and the repaint a good deal of original paint which had been needlessly painted over again came to light, the brush strokes being clearly visible once more. A number of other areas of damage, mainly at the top of the painting, were treated in the same way. All the places treated were rubbed with yellow turpentine. The painting now had to be fastened to a wooden frame or loom for relining, which involved facing the front of it with paper. As had been learned from the experience with the mulberry paper, the surface of the painting needed to be degreased first if satisfactory adhesion were to be obtained. A piece of rayon was used as a cloth instead of cotton wool since, because xylene evaporates quickly, fibrous remains of cotton wool are difficult to remove. Then the impasted parts of the paint layer were measured and marked out on a photograph of the painting, so that when it came to ironing later on, their position would be known. A cellulose paste was prepared, the paper was cut to size and a large loom was placed round the Night Watch. Each band of paper was 25 cm longer on either side than was necessary for pasting it to the loom. No

Afb. 13. De oude beschadiging bij de schutter met de hoge hoed na verwijdering van de overschildering.

Fig. 13. Old damage near the militiaman with the tall hat after the removal of the repaint.

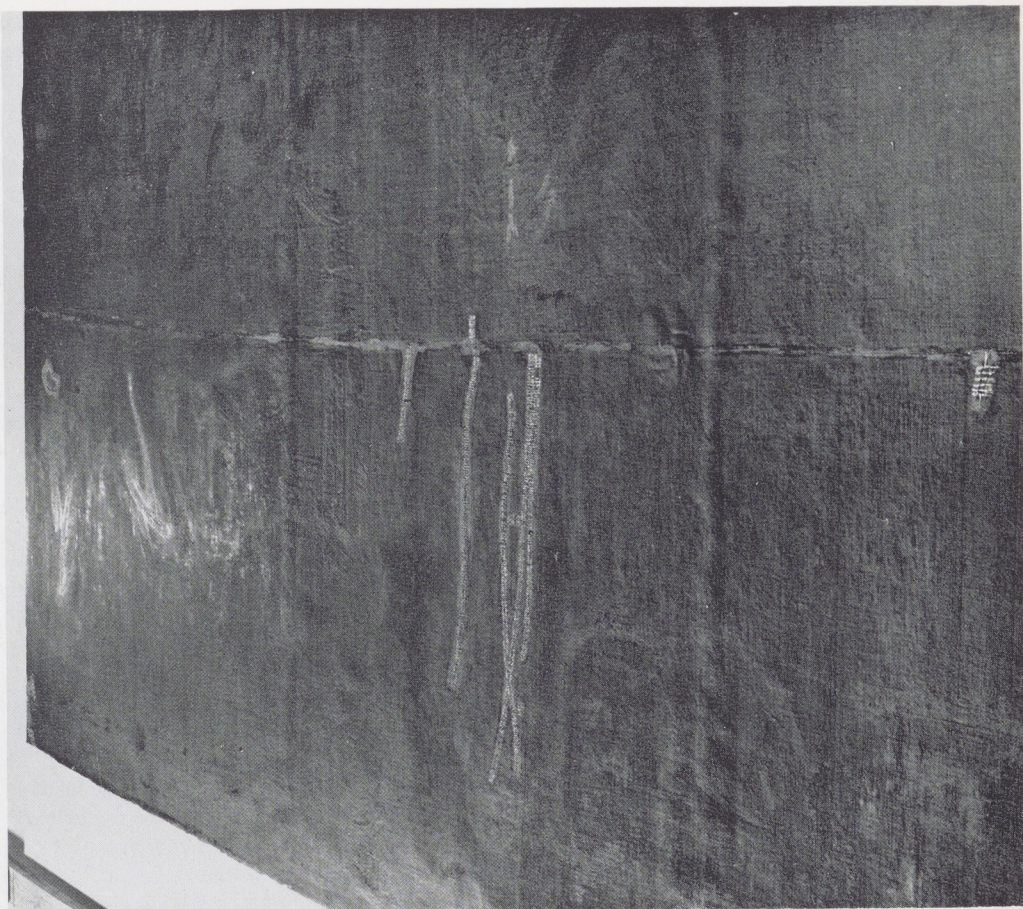
Afb. 16. De luchtbuizen, ontstaan bij het beplakken, zijn aan de achterkant zichtbaar.

Fig. 16. The long air pockets formed during the facing of the painting visible on the back.

After a time it was found that long pockets of air had formed over the whole length of the overlaps to the left and right of the central band of paper (Fig. 16) and this had also happened with the wider overlaps at the sides, the paper having come away from the painting in those places. This was partly due to the age of the paper that had been used, which was worn along the edges, but the main cause was the fact that the softboard on the stretcher had warped from the effects of the moisture and had sagged downwards a little, so that the centre of the painting was also sagging through to some extent. The broad overlaps at the sides of the painting had dried more slowly than the ends projecting towards the loom, while the layer of paper applied to strengthen the ends had deliberately been pasted to them while they were still rather damp. Because of this a pull must have been exerted on the slightly sagging painting during drying and since the overlaps of the bands of paper were still not completely dry at that point, the paper must have been drawn away from the painting at those places, so that air could get underneath. That air pockets should have formed in this way was most disappointing.

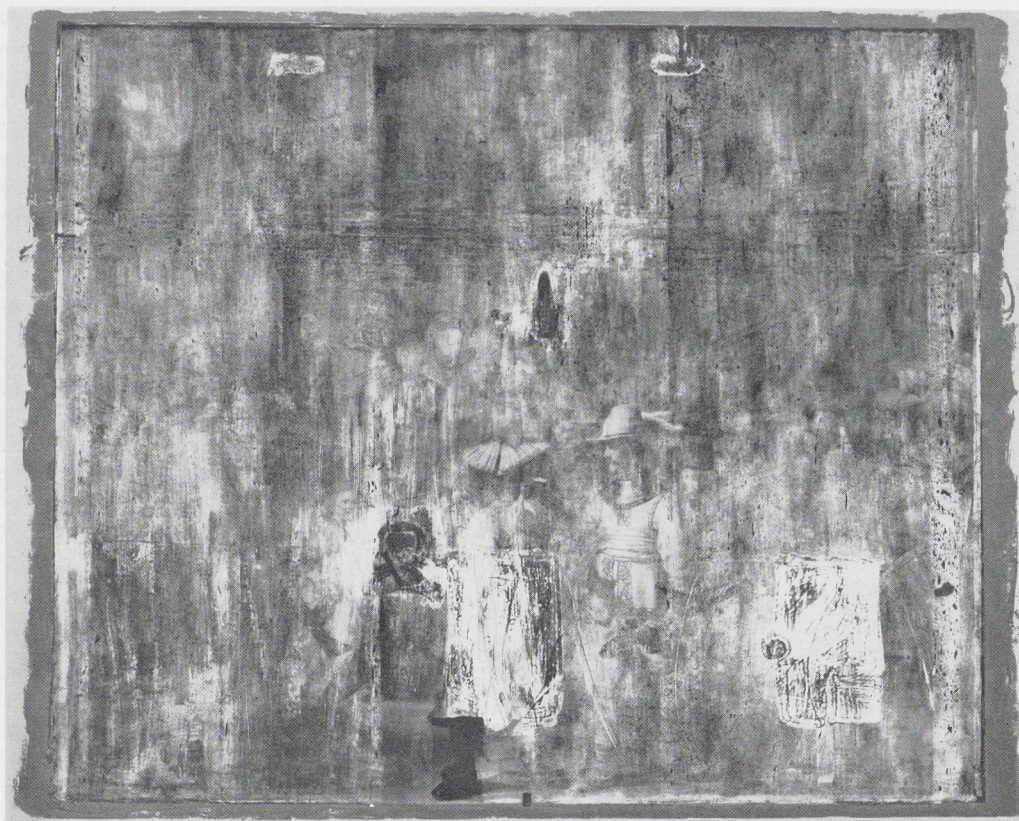
After ironing the relined painting was cut away from the loom, so that it was fastened only to the relining frame. This was turned over, so that the front of the painting faced with paper was again uppermost and the paper was pulled off without being moistened. The varnish had totally disintegrated and turned white because of the action of the water in the paste (Fig. 19).

Fig. 19. The front of the painting after the removal of the paper. The disintegrated varnish has been regenerated with alcohol over Banning Cocq's right foot.

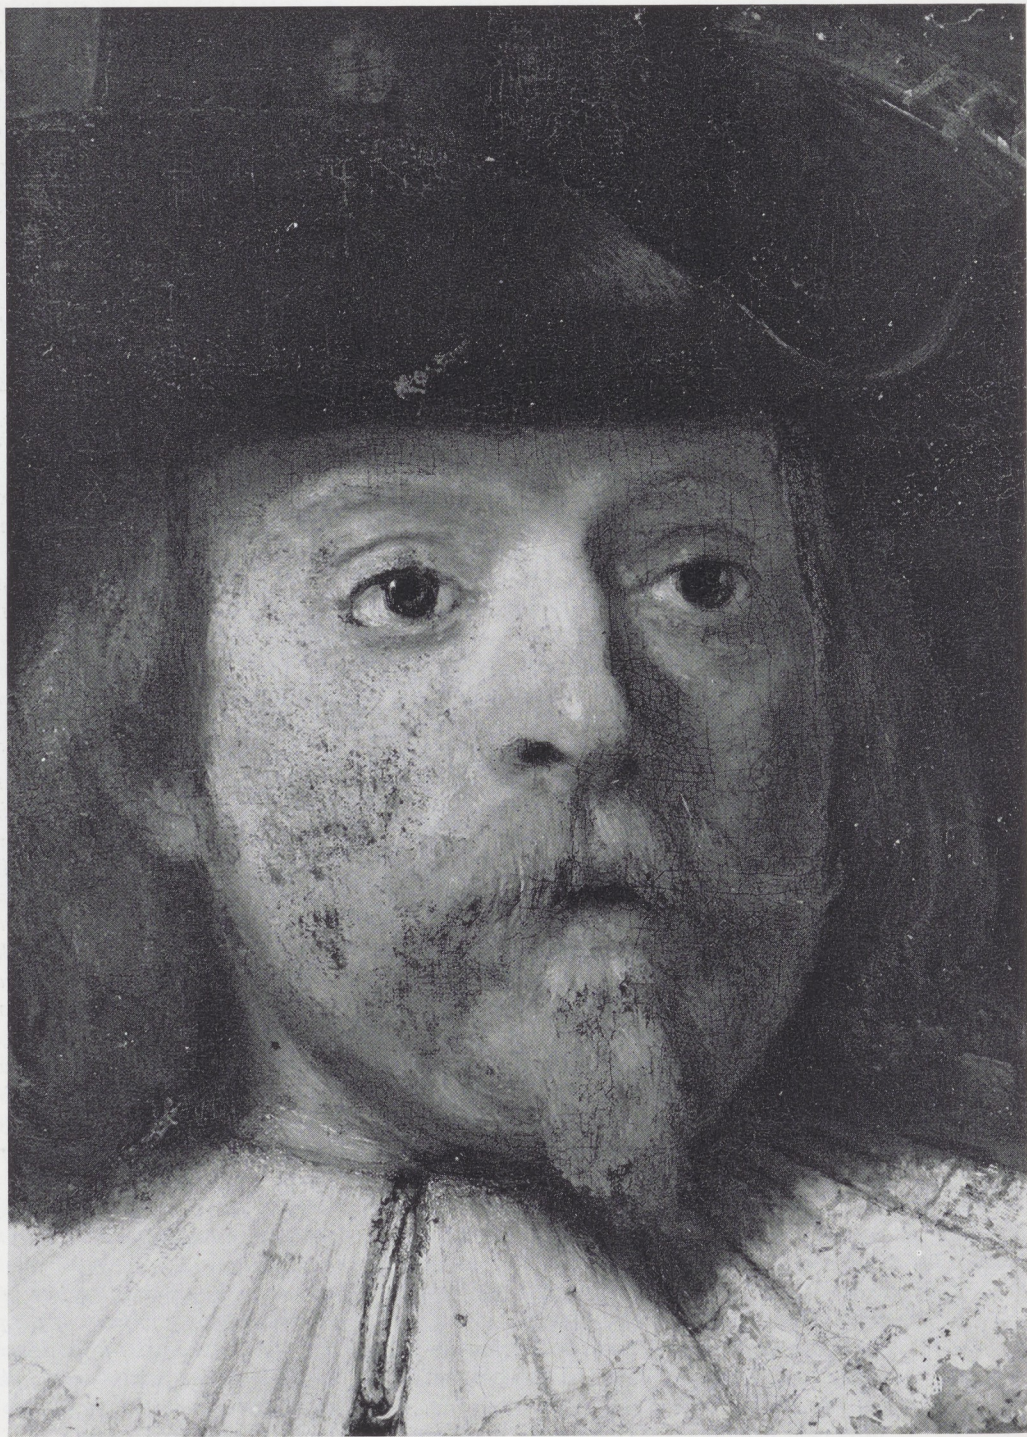
Fig. 22. Banning Cocq's head as it appeared after the removal of the old varnish.

damage was touched in, so that it can now scarcely be discerned without a magnifying-glass. This was done, for example, in Banning Cocq's right cheek (Figs. 22 and 23) and in some of the other faces. Bare and abraded areas, such as Banning Cocq's black suit, the brim of Rombout Kemp's hat (he is the militiaman standing on the right, who is looking

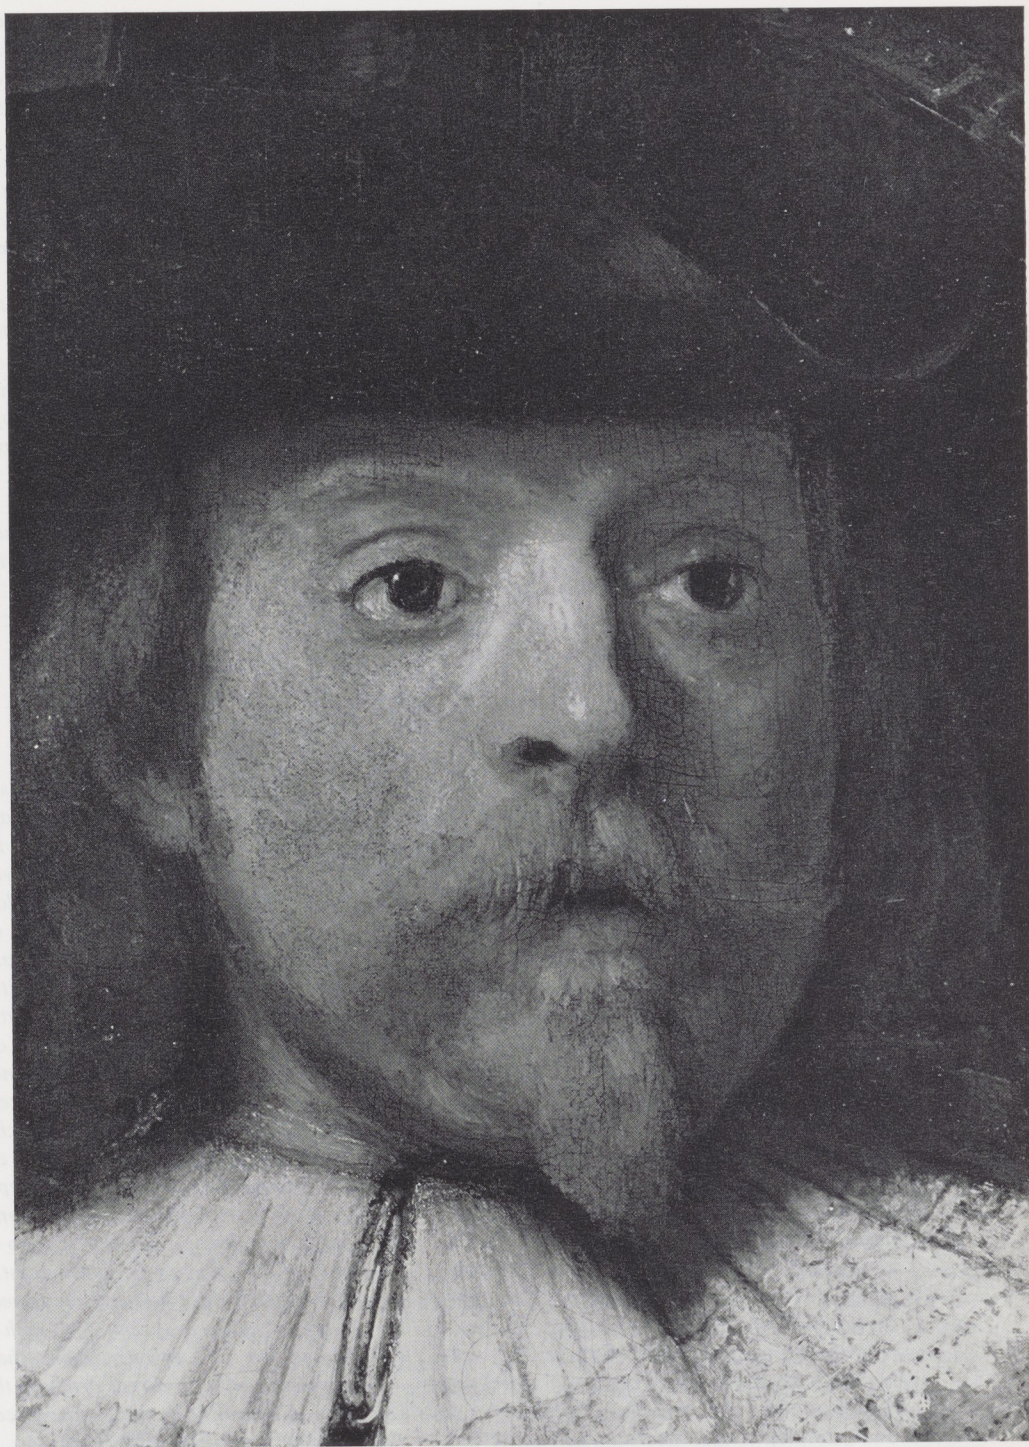
Afb. 23. De kop van Banning Cocq, na het aanbrengen van retouches.

Fig. 23. Banning Cock's head after retouching.

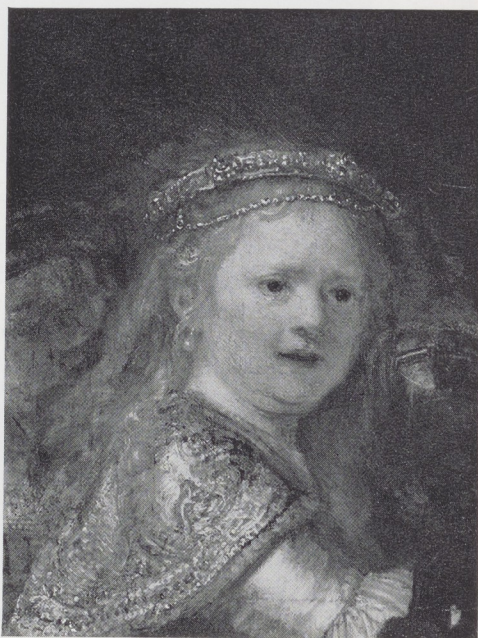
Afb. 25. De plaats van afb. 24 na het aanbrengen van retouches.

Fig. 25. The area in Fig. 24 after retouching.
