The restoration of *Woman in Blue Reading a Letter* by Johannes Vermeer*

Preliminary Research and Condition before the 2010-11 Restoration

The 2010-11 Restoration

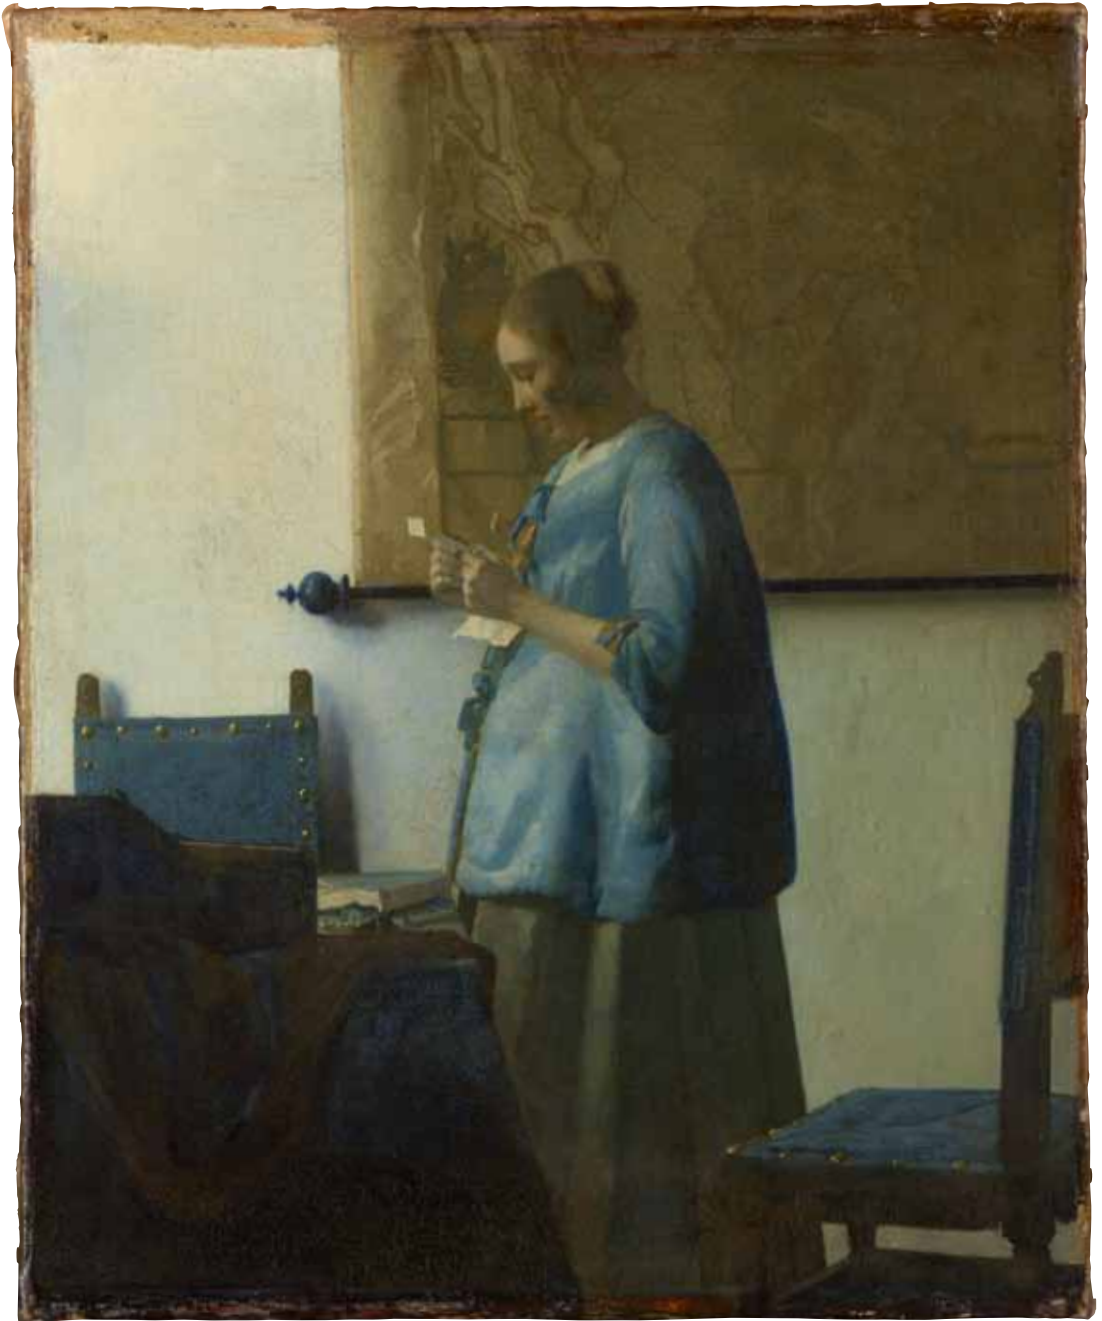
Fig. 1

JOHANNES VERMEER,
*Woman in Blue
 Reading a Letter*,
 c. 1663-64.
 Oil on canvas,
 49.6 x 40.3 cm.
 Amsterdam,
 Rijksmuseum,
 inv. no. SK-C-251;
 on loan from the
 City of Amsterdam
 (A. van der Hoop
 Bequest).
 Photograph before
 the 2010-11 restoration.

The yellowed oxidized natural resin varnish fluoresced bright green in UV light (fig. 7). The patchy fluorescence indicated that the varnish was uneven in thickness, fluorescing more strongly where there was more oxidized varnish, resulting in uneven yellowing of the varnish layer (fig. 1). The stronger fluorescence in the lower part of the painting, indicating the presence of more varnish in this area, was the result of the 1962 cleaning, which only partially removed the old varnish at the bottom of the painting.

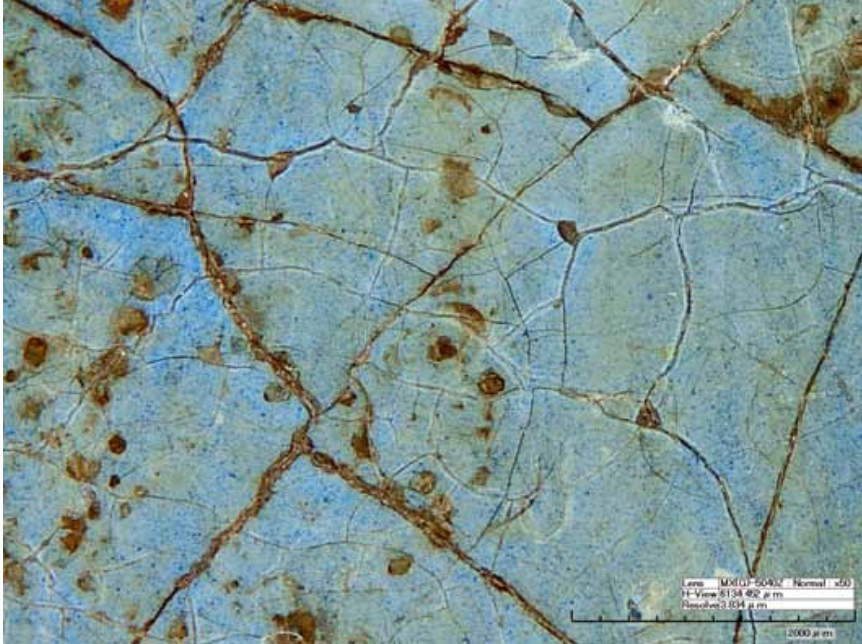
Various areas of the paint surface, not confined to any particular colour or part of the painting, show tiny circular losses in the paint layer. These small circular losses, filled with dirt and residues of discoloured varnish, were most noticeable in the light wall on the left side, above and on top of the table and in the lighter blue areas of the jacket (fig. 2). Under magnification it was noted that small blisters of paint were present in certain areas next to these losses (fig. 3).

Fig. 2
Photomicrograph from a light blue area of the jacket, showing small circular losses in the paint layer, filled with varnish and dirt (Hirox 3D, 50x magnification).

Once the painting was cleaned (fig. 12), the old loss at the bottom was clearly visible, and it also became obvious to what extent the numerous tiny holes interfered with the legibility of the painting. These small holes needed to be concealed, and it was decided to do so with a gouache paint, as this material has a certain 'body' that also acts as a filler. Because the holes were so small, this part of the inpainting was done under the microscope. The large loss at the bottom was filled and subsequently covered with gouache paint. To imitate the structure of the original paint surface on top of the filler material, a silicone mould was made of the original paint surface elsewhere in the painting and pressed into an acrylic binder applied on top of the gouache base. Several seventeenth-century Spanish chairs were studied, as was Vermeer's depiction of them in other paintings, in order to understand their construction. With this knowledge, and the fragments of original paint that were previously

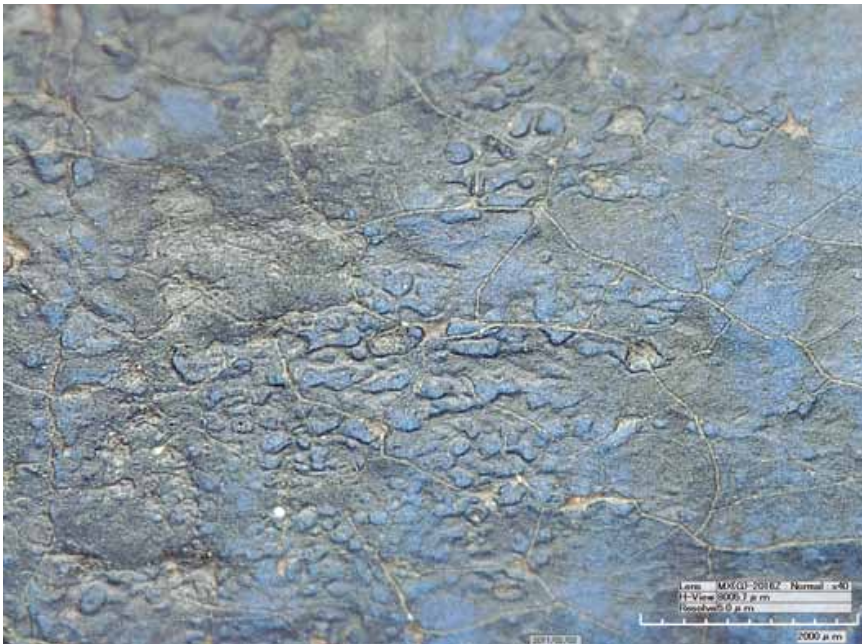
Fig. 3
Photomicrograph from the blue tablecloth showing small blisters of paint in addition to the small circular losses in the paint layer (Hirox 3D, 40x magnification).

These small blisters of paint, resulting in a raised and bubbled surface of the paint layer, resemble paint surfaces in other paintings that have suffered from overheating.¹³ A paint sample taken from a damaged area in the

This revealed that the paint layers were quite extensively deformed, indicating exposure to a high temperature. It also became obvious that the damage to the paint was not confined to the blisters and holes on the surface but that the paint has an open structure (bubbles) throughout the paint layers, from the ground up to the paint surface.¹⁴ It appears that Vermeer's *Woman in Blue Reading a Letter* was once overheated, most likely during a lining procedure, causing the paint to blister. Some of these small blisters would then have erupted at the surface, leaving small circular losses in the paint surface. It is unclear when this damage occurred, but it must have been at least a century ago and before the 1928 lining, as the small losses in the paint layer are visible on a reproduction of *Woman in Blue* published in 1894 (fig. 4).¹⁵

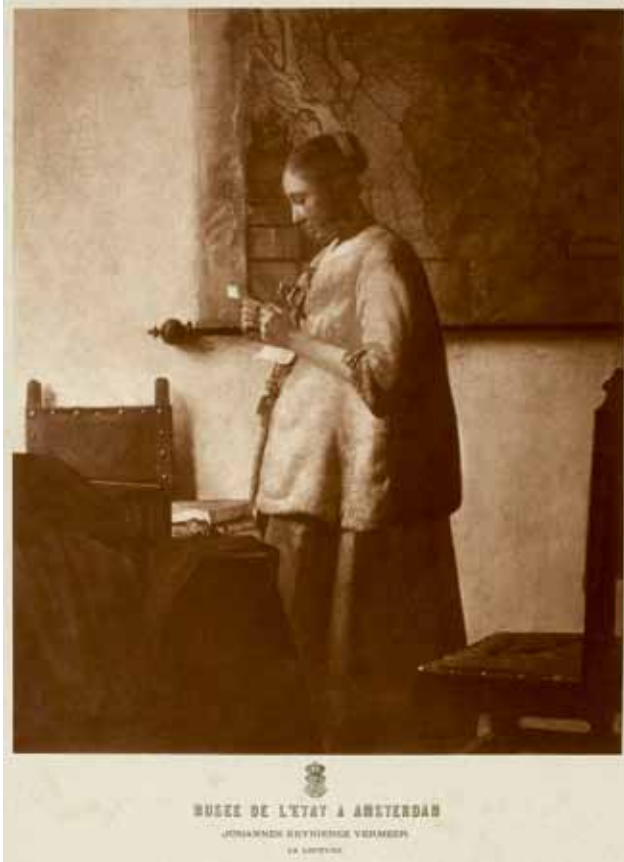
Fig. 4
1894 reproduction
of *Woman in Blue
Reading a Letter*.
Maison Ad.
Braun & Cte, Paris
and Dornach, Alsace.

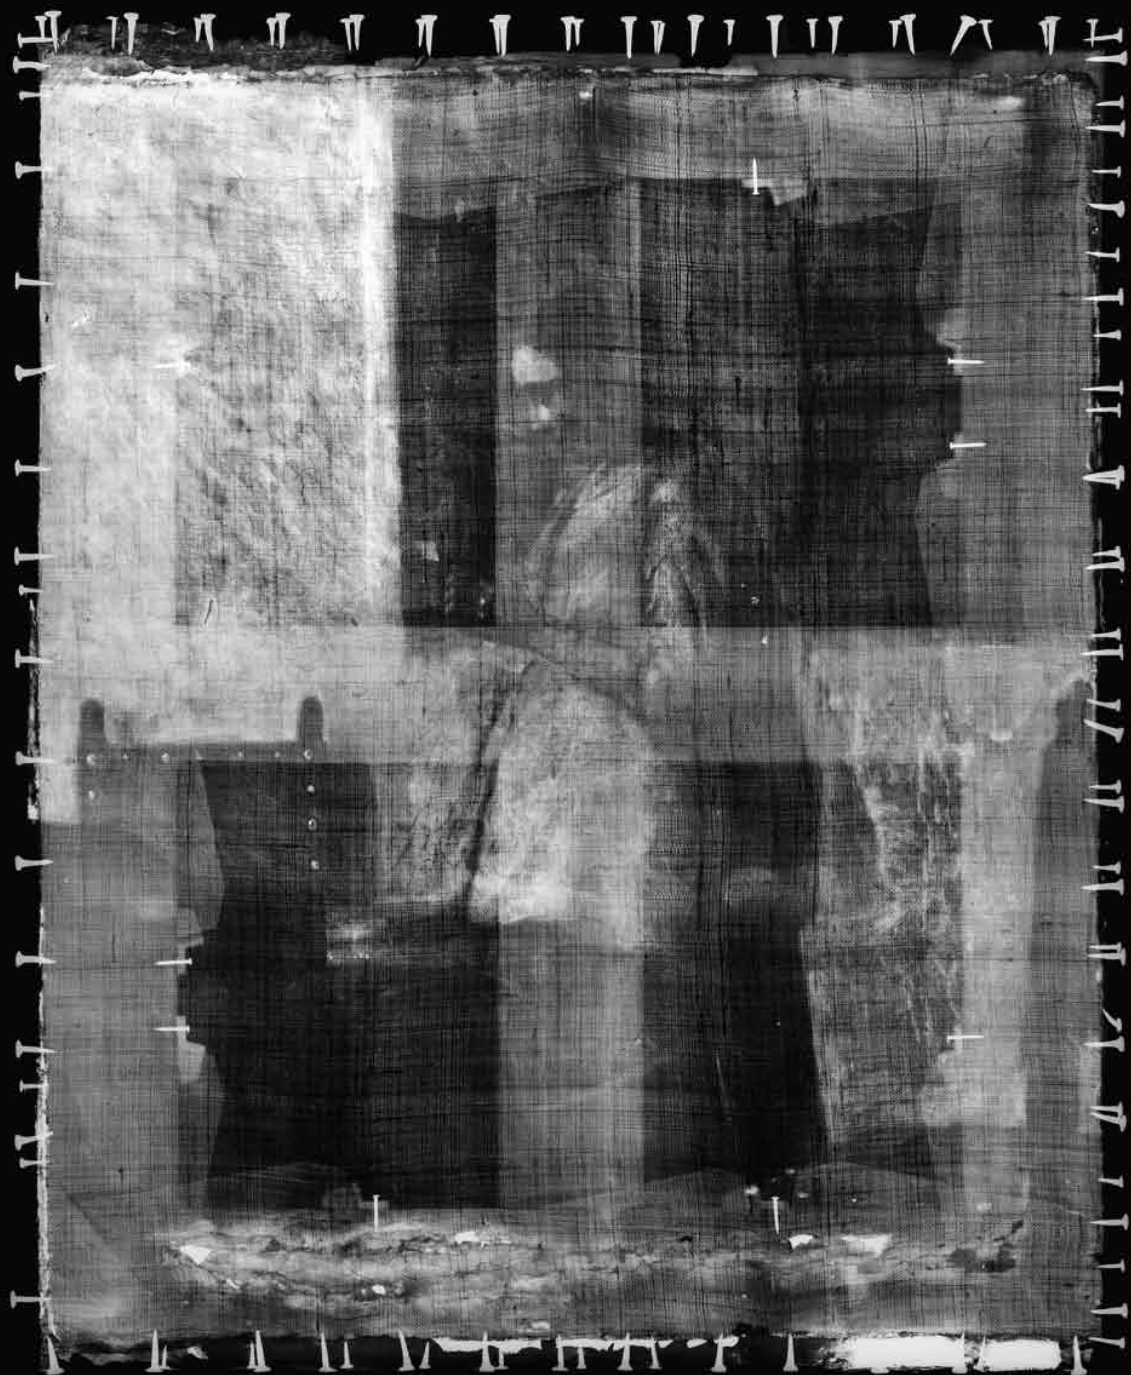
The paint surface is irregular along the bottom edge of the picture, showing large cracks and discoloured retouching and overpainting covering an old horizontal loss in the paint layer. This loss, just above the edge of where the original bottom member of the strainer would have been, is clearly visible in the x-radiograph (fig. 5). This damage may have occurred because the canvas was slightly slack on its strainer, allowing the canvas to move against the strainer bar, as well as enabling dirt, which would attract moisture, to collect between the bottom strainer member and the canvas. The damage is visible in the 1948 x-radiograph, but it had probably already occurred long before then, as reproductions from before 1948 show old restorations along the bottom edge. When the reproductions of *Woman in Blue Reading a Letter* made at different times are compared it is remarkable that in the earliest reproduction, the 1894 photograph (fig. 4), the chair leg next to the woman's skirt is wide, whereas the photographs published after 1928 reveal that the leg of the chair had been reduced in size. The retouches covering this old damage were severely discoloured, disturbing the legibility of the painting. In the IRK image (fig. 6) the retouch paint, which contained carbon, registered darker and was clearly visible, not only where it covered the old loss but also along the edges of the canvas, especially at the top of the painting.¹⁶ A comparison of the x-radiograph (fig. 5), which shows clearly where the original canvas ends, and the image of the painting before restoration (fig. 1) reveals that the original size of the composition was enlarged on all sides at a later date, especially at the top and bottom. This resulted in a rather elongated composition. The composition as Vermeer intended it is squarer, and this makes it a stronger and more intimate image.

Fig. 5
X-radiograph of
Woman in Blue
Reading a Letter.

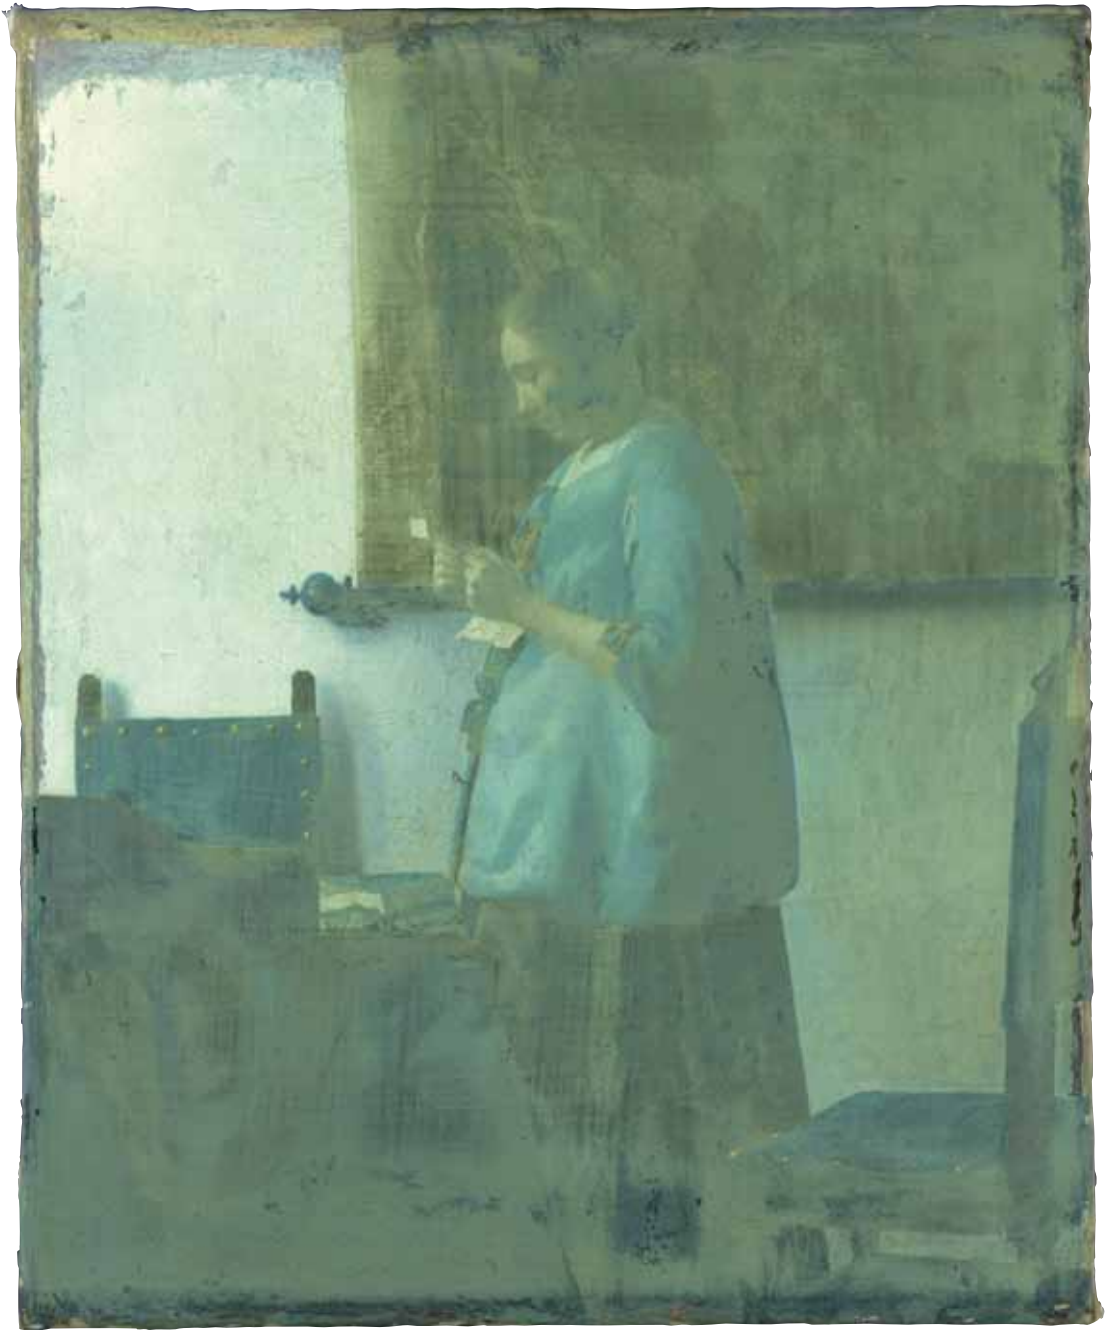
Fig. 7
UV photograph
of *Woman in Blue*
Reading a Letter.

It was decided to remove the old varnish layers so as to restore the intended cool tones of the painting and enhance the visibility of the finely executed paint surface. Old restorations along the bottom edge were to be removed, especially where original paint was covered, to regain as much of the original paint surface as possible. Uncovering all the remnants of original paint would make it possible to create an accurate reconstruction of the chair leg, the shape of which had been changed over time. It was also decided to remove all of the retouches and overpaints along the edges, which would result in a squarer composition as Vermeer intended. After cleaning, a new varnish would be applied to saturate the paint layers. The large area of damage at the bottom, old losses in the paint surface and the numerous tiny holes in the paint surface would be filled and retouched in order to restore the painting's legibility.

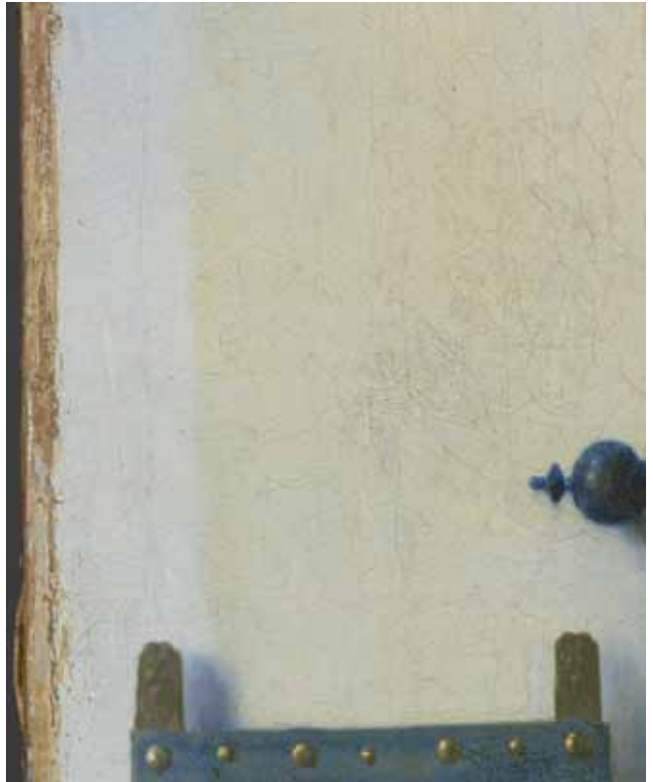
Fig. 8
Detail of the wall to the left of the woman during cleaning. On the left side the old yellowed varnish has been removed, revealing a cool blue tone.

After several tests, the varnish was removed with an organic solvent to ensure minimal mechanical contact with the fragile paint surface. The removal of the yellowed varnish revealed the intense blue hues and detailed paint surface (figs. 8, 9). The shift in colour was quite dramatic, particularly in the shadowed area of the figure's blue jacket. While the blue of the chairs

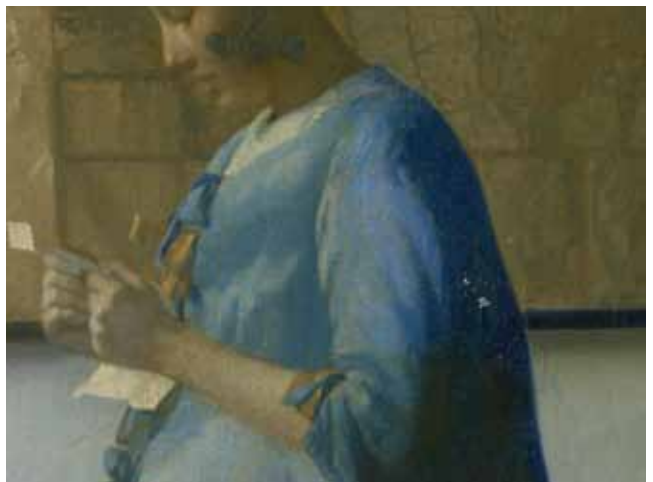
Fig. 9
Detail of the blue jacket during cleaning. The upper right corner has been cleaned, showing the dramatic shift in colour.

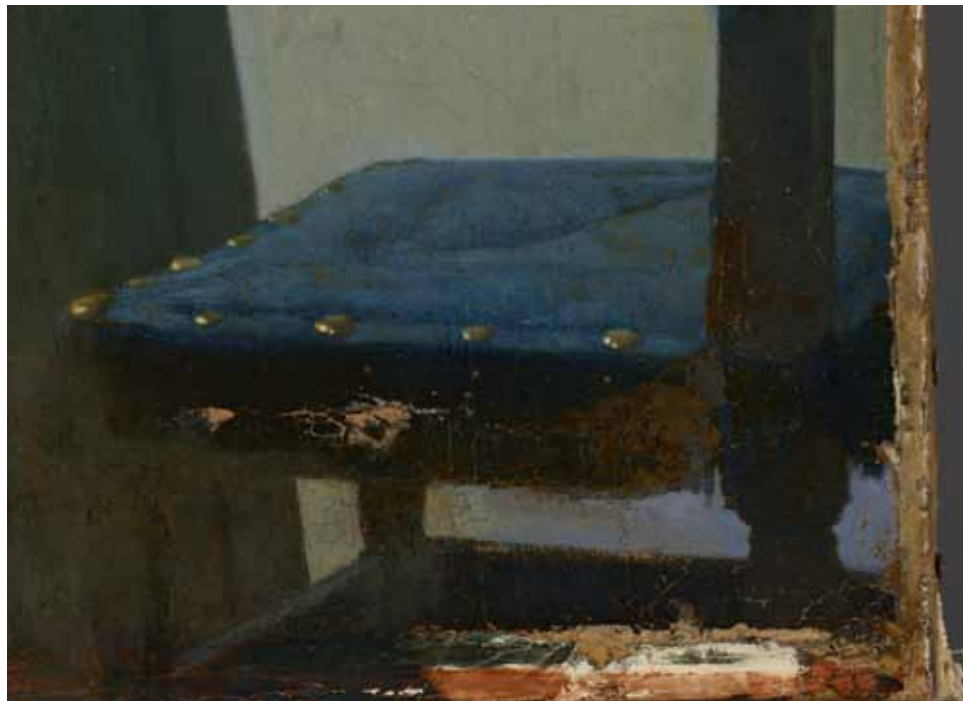
– delicate details painted by Vermeer that had been covered for decades – were revealed (fig. 10).¹⁷ It also became apparent that the area of the wall below the chair was originally a vibrant purplish blue, and that it had been painted over in the greenish-grey colour of the wall above the chair at a later date.¹⁸ The removal of a thin brown overpaint covering the brown cloth laid over the table revealed the original rounded folds with slightly different hues. The four yellow dots of paint on top of the table and the small stroke of yellow paint above the letter extended over cracks in the paint layer, indicating that they were not original. They were easily removed with solvent and it became apparent that, with the exception of the third dot of yellow, which had been applied directly on top of the light blue tabletop, they had been covering dots of original white paint. The dots of yellow paint must have been added at some time to transform the small dots of original white paint into a string of pearls (fig. 11).

Fig. 10
Lower right corner during cleaning. Discoloured varnish, overpaint and fill material are still present on the left. On the right they have been partially removed, revealing the small painted brass nails and the original purplish blue colour underneath the chair.

Once the varnish had been removed, it was also possible to remove the retouches and overpaints along the edges of the picture – exposing the bright orange filler material from a previous restoration – and some of the overpaints covering the damage at the bottom. Overpaint and overfill covering original paint along the large loss at the bottom, which could not be removed with solvents, were removed mechanically with a scalpel under the microscope. At least six different filler materials could be discerned in and around the large damage, evidence of several previous restorations. Where it was not covering original paint, old inert filler was left and used as a base for retouching. With the removal of the old restorations in the lower right corner came a surprising discovery: small painted brass nails in the chair

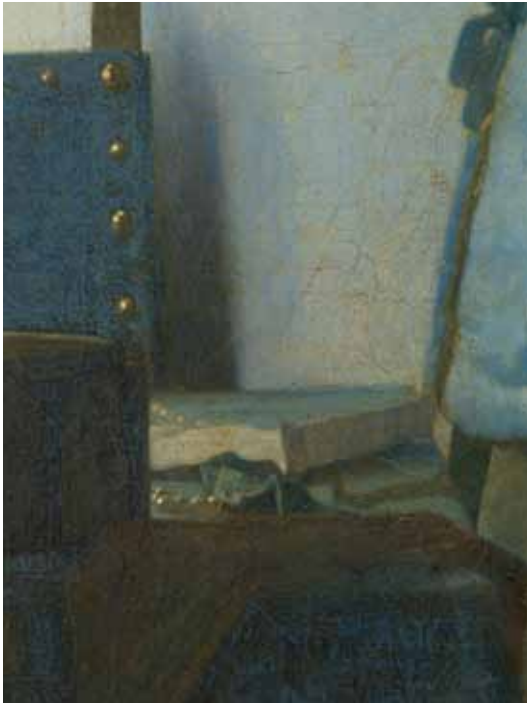
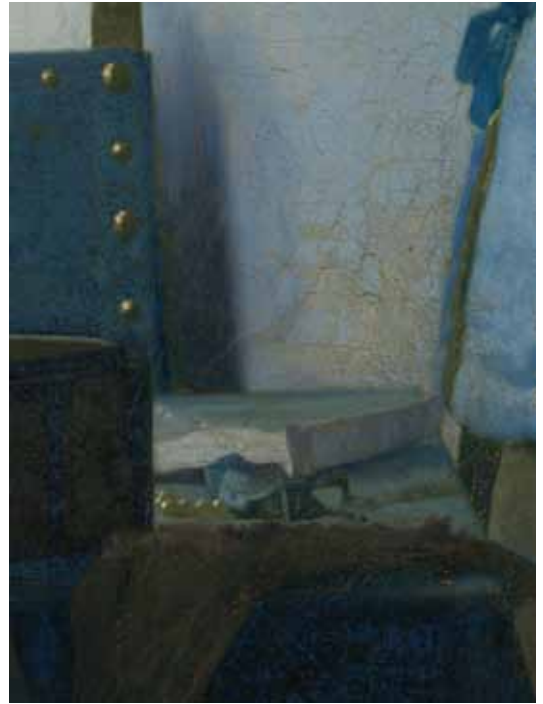
Fig. 11a, b
Tabletop before (a)
and after (b) cleaning.

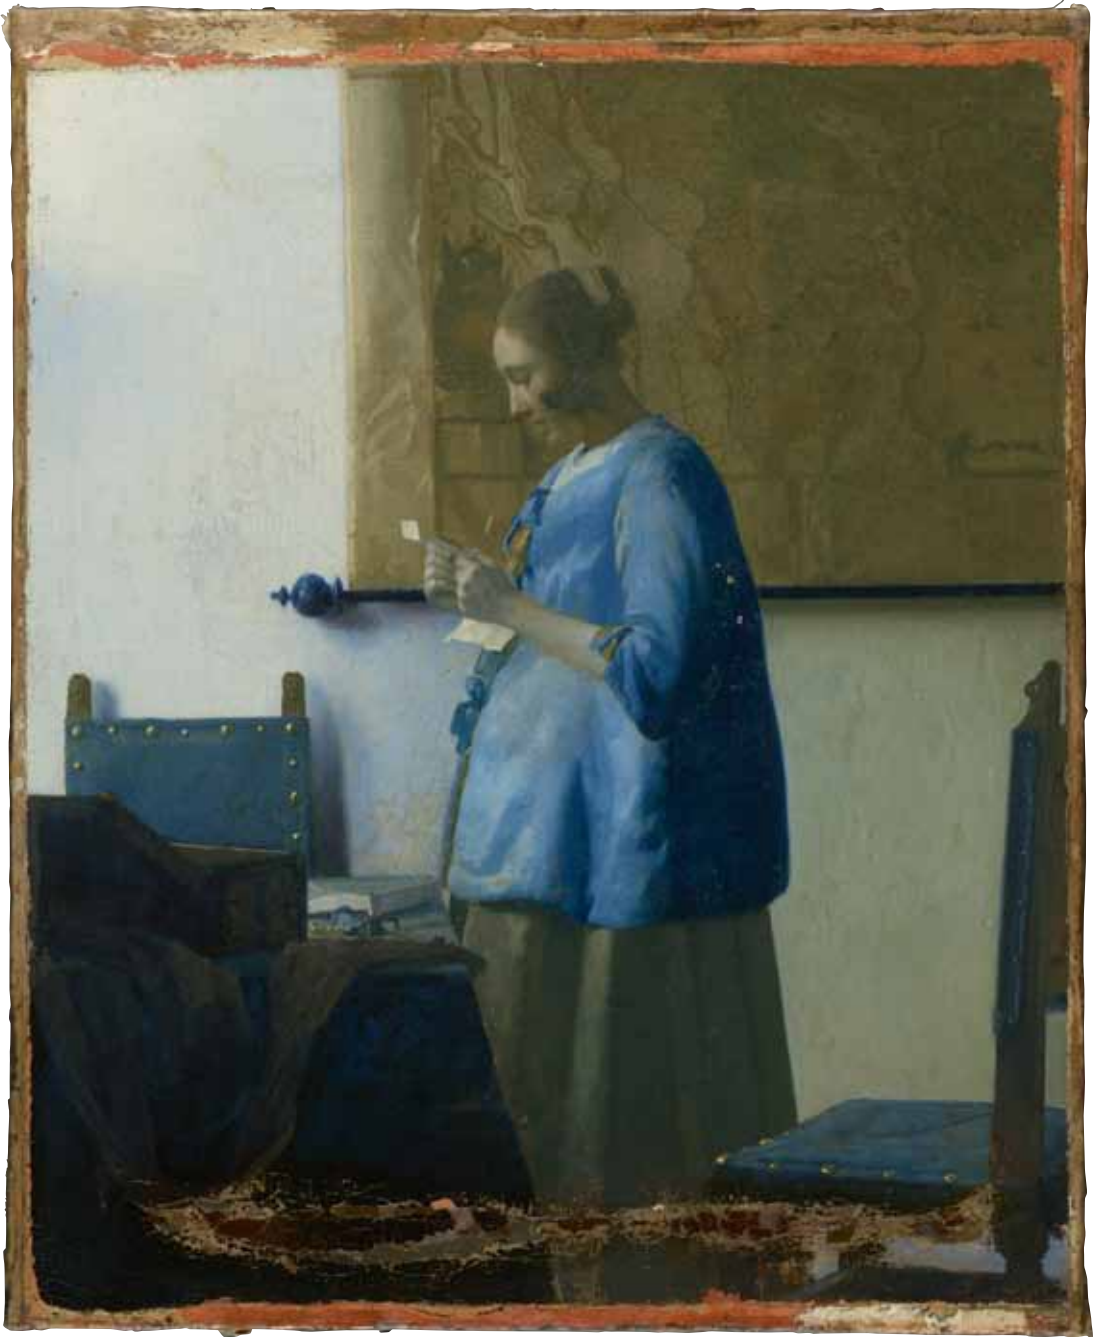
Fig. 12
Woman in Blue
Reading a Letter
after cleaning, before
filling and inpainting.

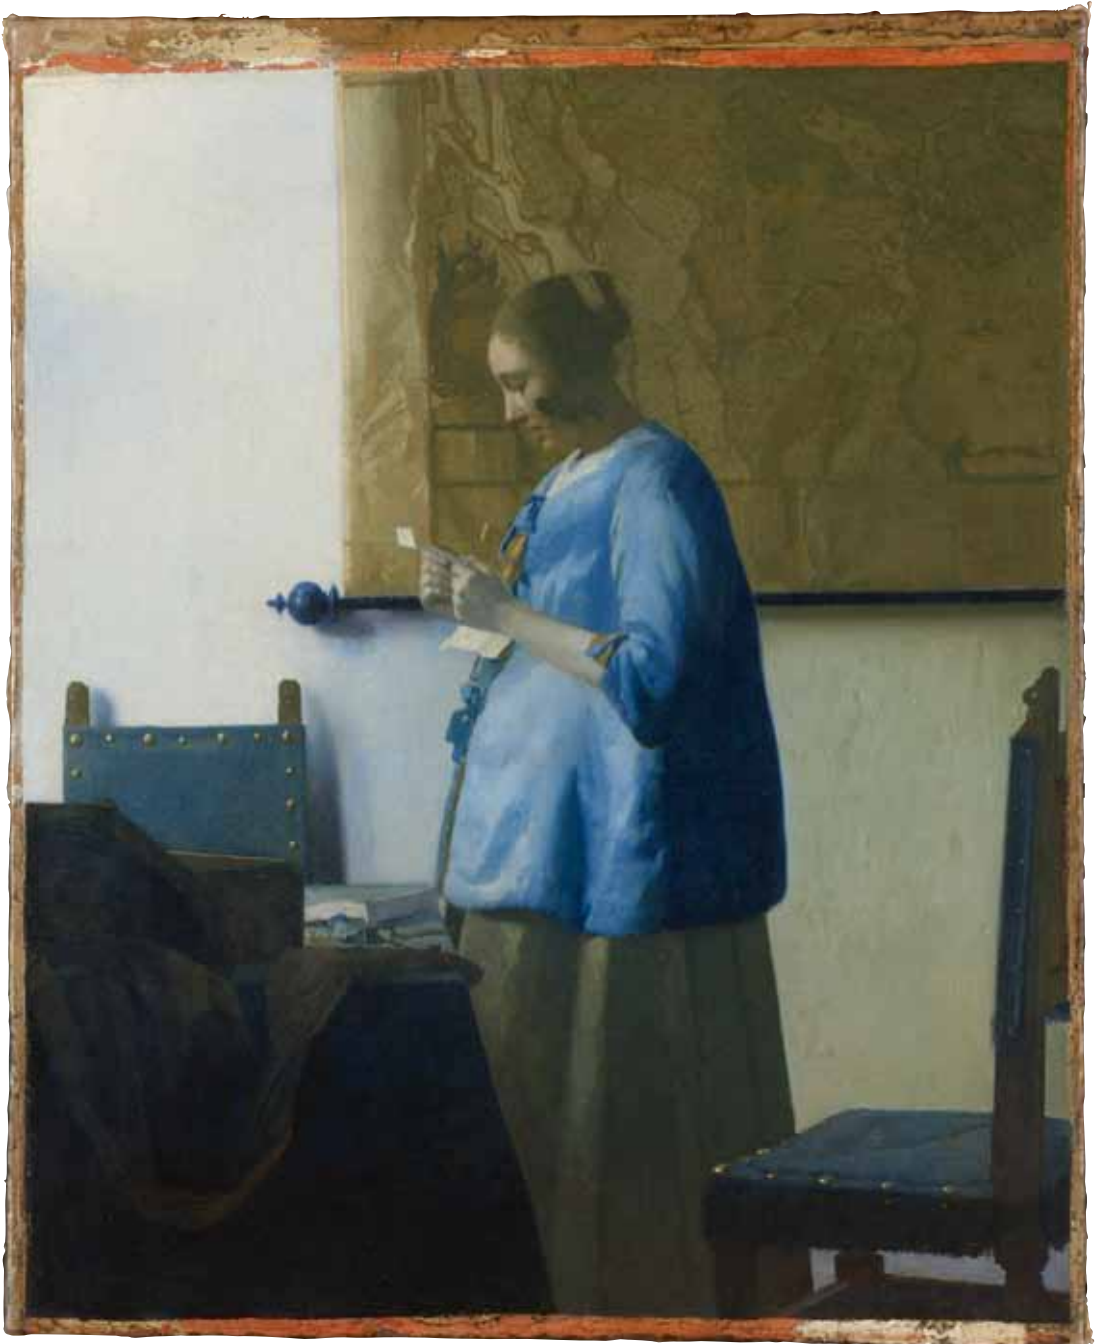
Fig. 13
*Woman in Blue
Reading a Letter*
after the 2010-11
restoration.

Before the final inpainting was carried out, a stable synthetic varnish was brush applied to saturate the colours. The application of this varnish served to level out the uneven surface of the painting caused by the tiny holes and blisters to some extent. The final inpainting was done with a stable synthetic resin and loose pigments in order to achieve optimal concealment of the damage and restore the legibility of the image (fig. 13). A final natural varnish layer was then brushed on to the surface to fully saturate the colours, to seal off all retouches and to even out any differences in gloss.²⁰

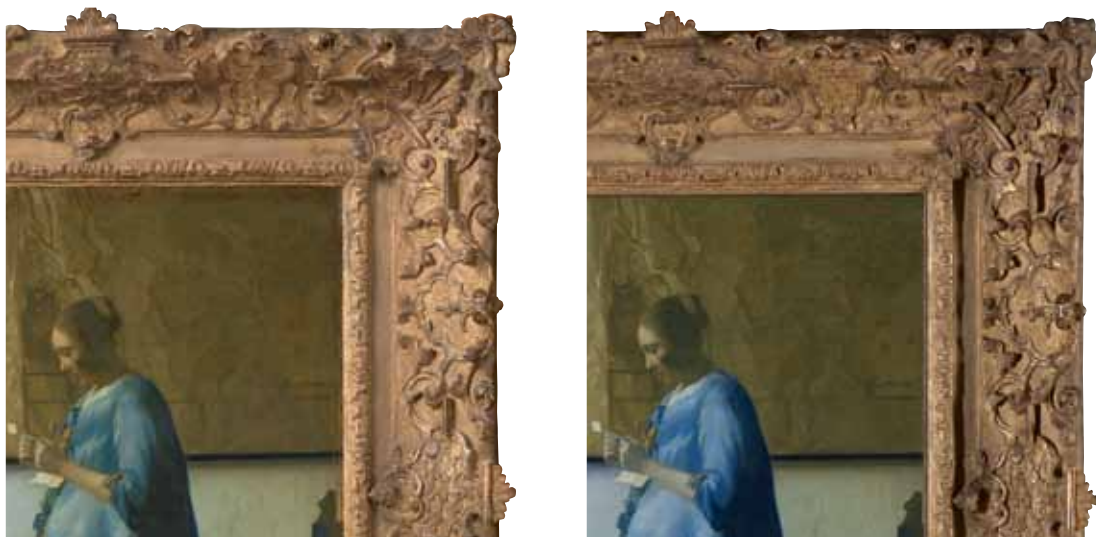
Fig. 14a, b
Upper right corner
of the French Régence
frame before (a) and
after (b) restoration.

the non-original extensions to the composition must already have existed by then. An extensive search for a suitable contemporary frame was subsequently coordinated by Hubert Baija, senior conservator of frames and gilding. In the end it was decided to try to adjust the sight size of the Régence frame. Since the sight size needed to be adjusted more at the top and bottom than at the left and right, there were initial doubts as to whether an asymmetrical inlay might be disturbing to the eye. Baija created a fine inlay, gilded and finished with a patina, which blends beautifully with the surrounding frame without attracting attention to it (fig. 14).²⁴
