The Conservation and Installation of the Beuning Room in the Rijksmuseum*

• PAUL VAN DUIN •

The conservation and installation of the Beuning Room in the Rijksmuseum, a complex and challenging project, were undertaken between 2009 and 2013. The most important elements of the room – the chimney-piece, double doors and pier-glasses – had previously been restored in 2001 for the exhibition *Rococo: A Riot of Ornament*.¹ In the light of the success of this display and the long-held wish to show the room to the public again, in 2006 the Amsterdam Museum ceded the room to the Rijksmuseum on long-term loan. The museum's eighteenth-century galleries now contain two important period interiors – the Beuning Room and the late eighteenth-century Kops Room – enabling the public to see two of the most beautifully executed Dutch eighteenth-century interiors. Visitors are free to walk around the Beuning Room to enjoy the architecture and the sumptuous ornament of both the Cuban mahogany panelling and the plasterwork on the ceiling. In this article we look at the decisions that were taken during the conservation and installation of the Beuning Room and compare them with the installation of the roo

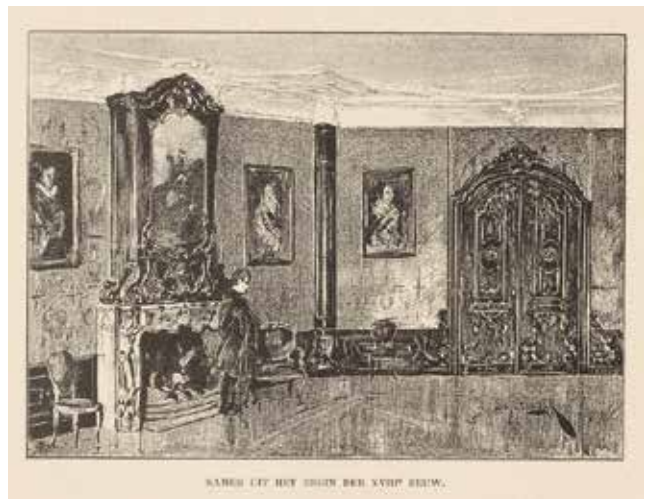
Fig. 2
Drawing by
Willem Steelink in
A.W. Weissman,
*Het Amsterdamse
woonhuis van
1500-1800, from
Jaarverslag van het
Koninklijk Oudheid-
kundig Genoot-
schap 27 (1885), p. 46.*
Koninklijk
Oudheidkundig
Genootschap, inv. no.
KOG-ZG-I-XXVA-14.

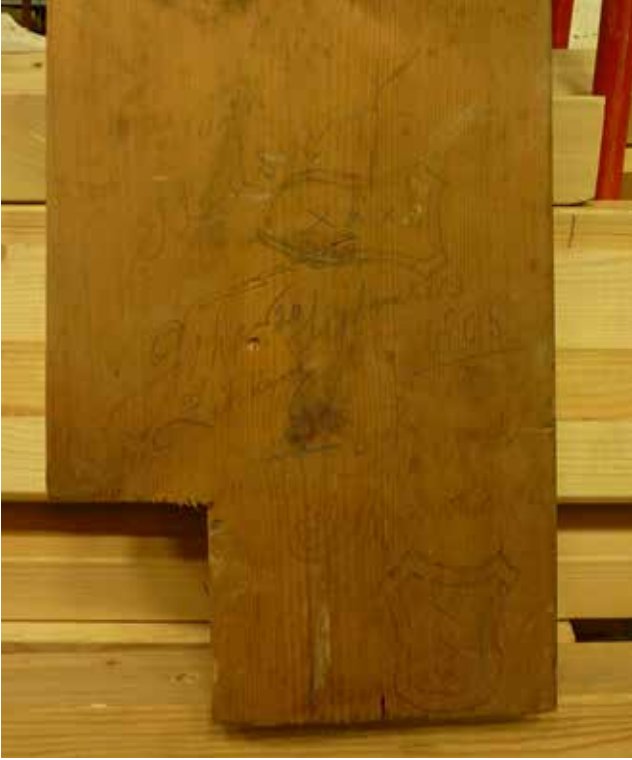
Fig. 3a
Inscription on a beam on which the ceiling was suspended in the Stedelijk Museum: 'Stedelijk Museum Johan Zikking 20 September 1896 Stad Amsterdam' with the arms of Amsterdam twice.

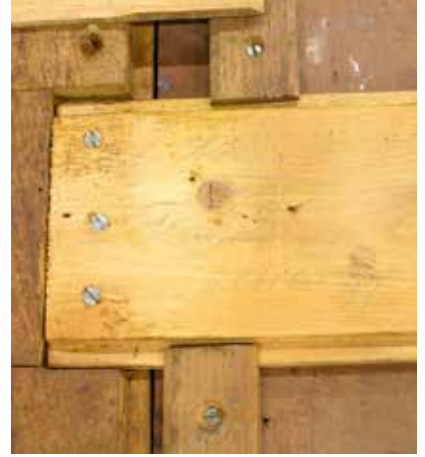
Fig. 3b
Inscription on the inside of the former cupboard door: 'Zikking Timmerman 4e October 97'.

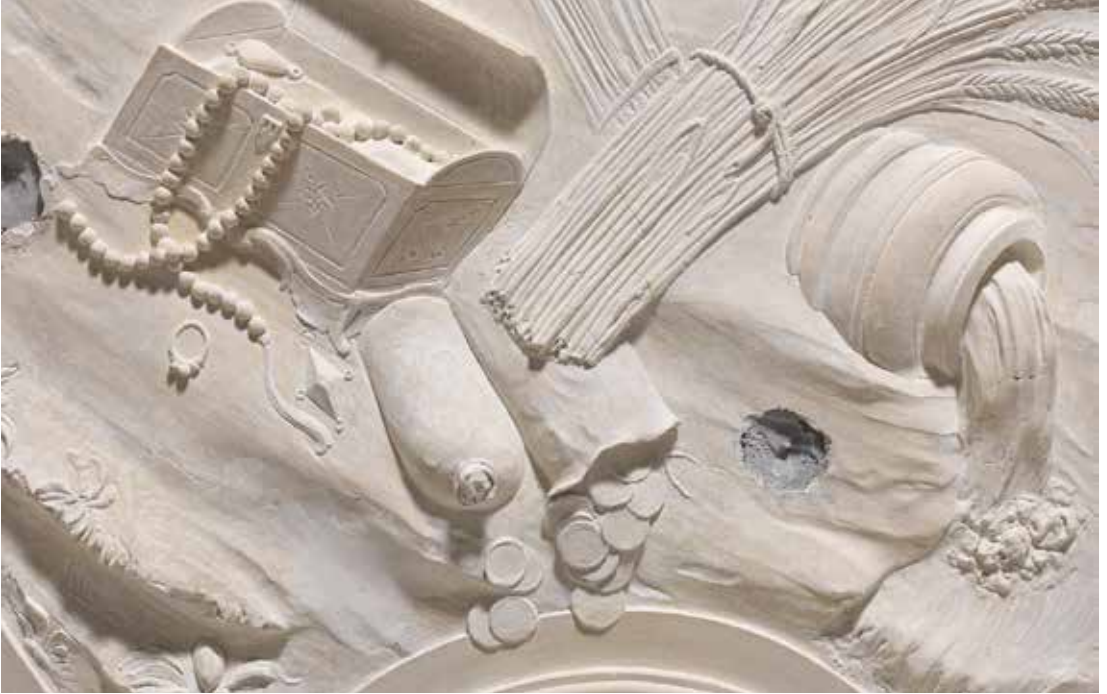
Fig. 5
Detail of the ceiling, after removal of the coats of whitewash, revealing the superb quality of the decorations – and two holes left by the bolts with which the ceiling was secured to the beam framework in the Stedelijk Museum, still filled with grey mortar.

The parts of the ceiling were very dirty and badly cracked. At the start of the conservation process, it was found that stud bolts had been used to attach them to the beam structure in the Stedelijk Museum. This consisted of eleven tall beams with a square beam on either side that acted as supports for short horizontal joists at right angles to the long beams. Some 250 bolts, 10 mm thick with a square head, had been put in through the plasterwork and the original boarding. For this purpose, the plasterwork had been removed down to the wood for each bolt, a hole had been drilled in the boarding, and the bolt, with a washer under the head, had been screwed into the beam. The head was covered with grey mortar and the hole that was left was filled with gypsum plaster (fig. 5). Similar plaster was also used to fill the joins and irregularities and make good partially missing mouldings and ornaments. As the ceiling parts were packed upside down in their crates, the beams were now suspended from the plaster ceiling. It was decided to remove these heavy beams. This was done by loosening the stud bolts where possible, but more often by sawing through the bolts between the later beams and the original boarding.

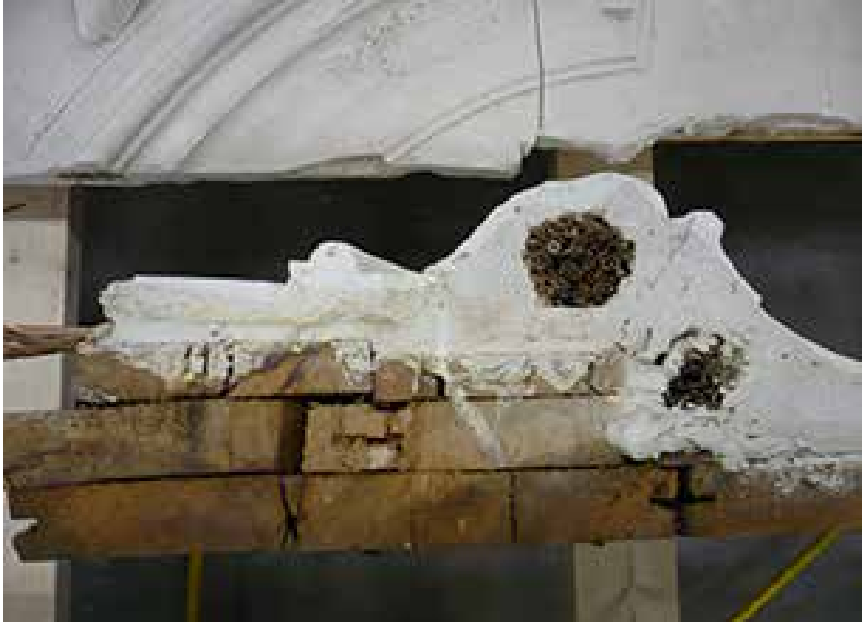
Fig. 6

Side view of a piece of ceiling, with the heavy plaster moulding that frames the oval central field. Three different layers of boarding for the different levels of ceiling can be seen. The top planks carry the plasterwork of the oval central field, the boards in the middle are the basis of the surrounding fields. The lowest planks are the basis for the framing of these fields. The bound bundles of reeds in the mouldings are also visible.

The removal of the beams made it possible to better understand the original construction of the ceiling. The plasterwork was applied on boarding of joined planks 3 cm thick and 27-30 cm wide. Reeds were attached to the boarding with copper wire and nails to serve as an anchor for the first, quite coarse, layer of lime plaster. The mouldings have a core of reeds bundled together with copper wire, which acted as anchors but also saved on plaster and kept the weight of the ceiling down (fig. 6). The layer was applied around this in the shape of the moulding. The flat and moulded elements were then finished smoothly with a layer of very fine stucco. The ornaments were added, modelled in

plaster, as Van Someren Brand wrote, with a charcoal underdrawing, which could be seen where ornaments had come loose. The shape of the concave coving was determined by the wooden ribs to which the planks were nailed. The rectangular, 'flat' part of the ceiling has three different levels, corresponding with the levels of the planks that make up the boarding. The triangular fields in the corners, with symbolic images, are the middle level, their framing is 3 cm lower and the oval central field is 3 cm higher than the triangular fields (fig. 6). Only two joists of the attachment of the boarding to the original beam structure have survived. They hung on a small vertical beam with a dovetail joint. Only the dovetail remains.¹³ Elsewhere many remnants of thick forged nails can be seen; they correspond with Van Someren Brand's observation that the boards were attached to each beam with seven nails.

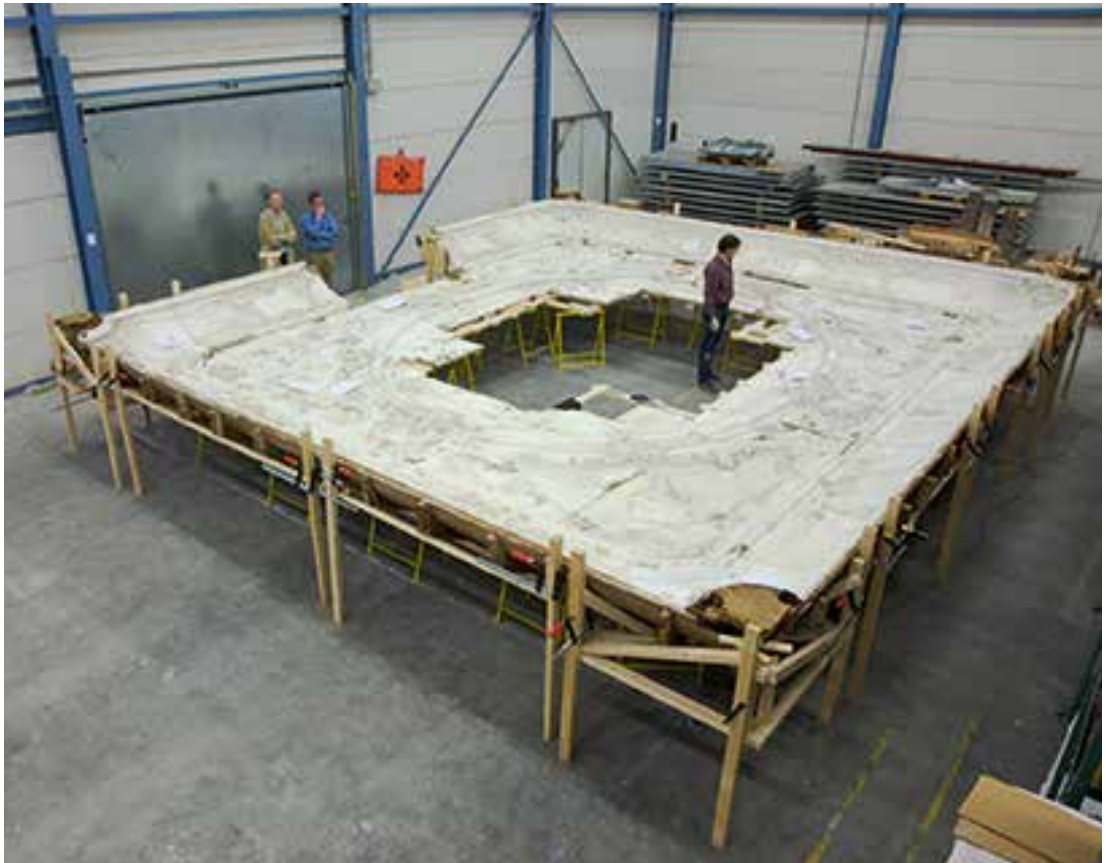
Fig. 7
After the Stedelijk Museum beams had been removed and the structure and plasterwork consolidated, the ceiling was placed on trestles to establish the correct dimensions and shape of the ceiling – and thus the floor plan for the walls.

When the beam structure was removed, it emerged that the highest planks of the boarding were interrupted where the beams ran. These planks had probably not been allowed for in calculating the height of the supporting structure. Sawing out and removing these pieces without damaging the plasterwork must have been a complicated job. In order to stabilize the extremely fragile ceiling pieces, they were screwed to new wooden frameworks during the recent conservation. The twenty pieces of the rectangular, 'flat' part of the ceiling were put together on eight frames, considerably reducing the number of individual ceiling parts. Extra ribs were screwed to the boarding to stabilize the structure of the fourteen parts of the coving. Once all the remnants of the 1896 beams had been removed and the structure of the parts of the ceiling had been stabilized, the ceiling elements could be laid side by side so that the dimensions of the ceiling could be established. This was done by laying

the ceiling – still with the plaster surface up – on trestles (fig. 7). The coving elements were supported on struts. Because the corner cabinets abut the corner pieces of the ceiling, it was possible to work out the floor plan. The cornices of the cabinets were fitted on to the ceiling and the distances between them measured.

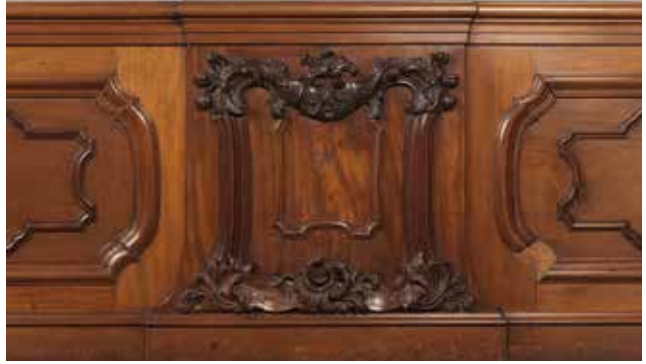
Fig. 8a
Panelling added in 1896 underneath the bay window in the Stedelijk Museum.

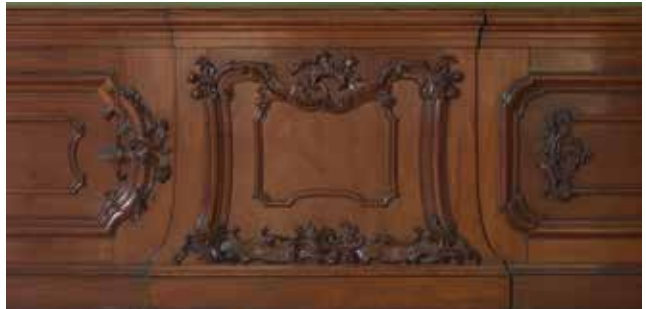
Fig. 8b
Original panelling of the wall opposite the windows.

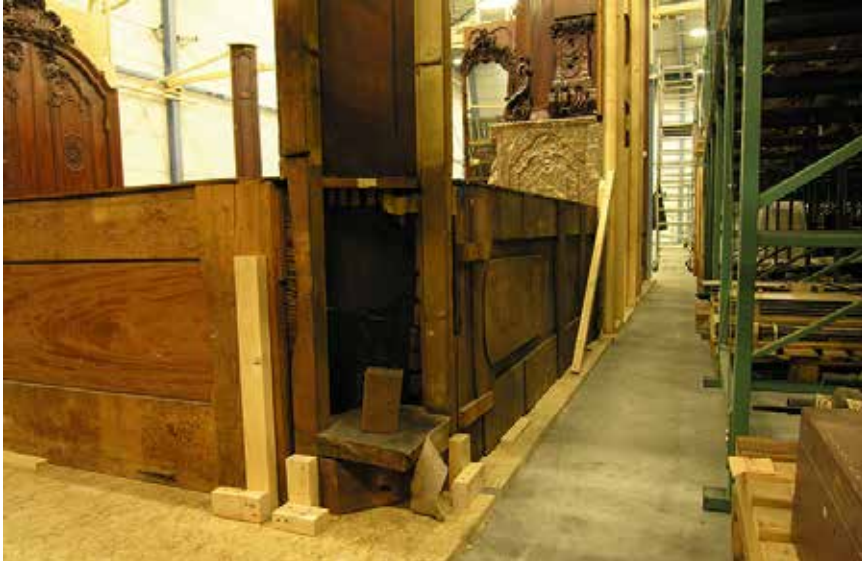
Fig. 9
Back of the corner cabinet and panelling by the former cupboard door, in the trial set-up in the Rijksmuseum repository. The back of the panel on the left of the corner cabinet looks much fresher and cleaner than the panel between the corner cabinet and the chimneypiece.

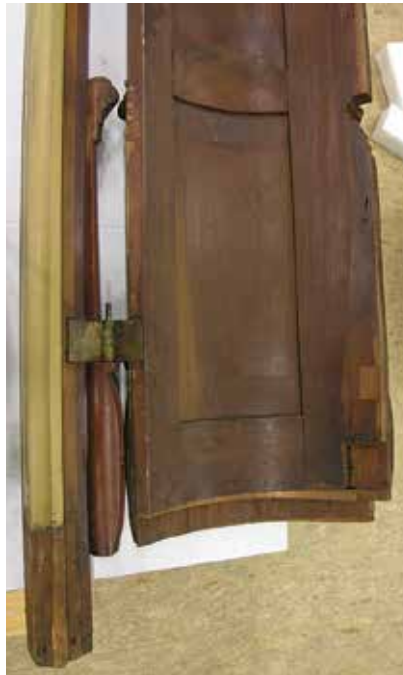
Fig. 10
Inside of the door with the corner post of the corner cabinet on the right-hand side of the window wall. At the bottom of the door there is a cut-out for a missing espagnolet lock. Above it is a lighter-coloured inset block of mahogany to fill the place of a former hinge of the shutters that were stored in the cupboard.

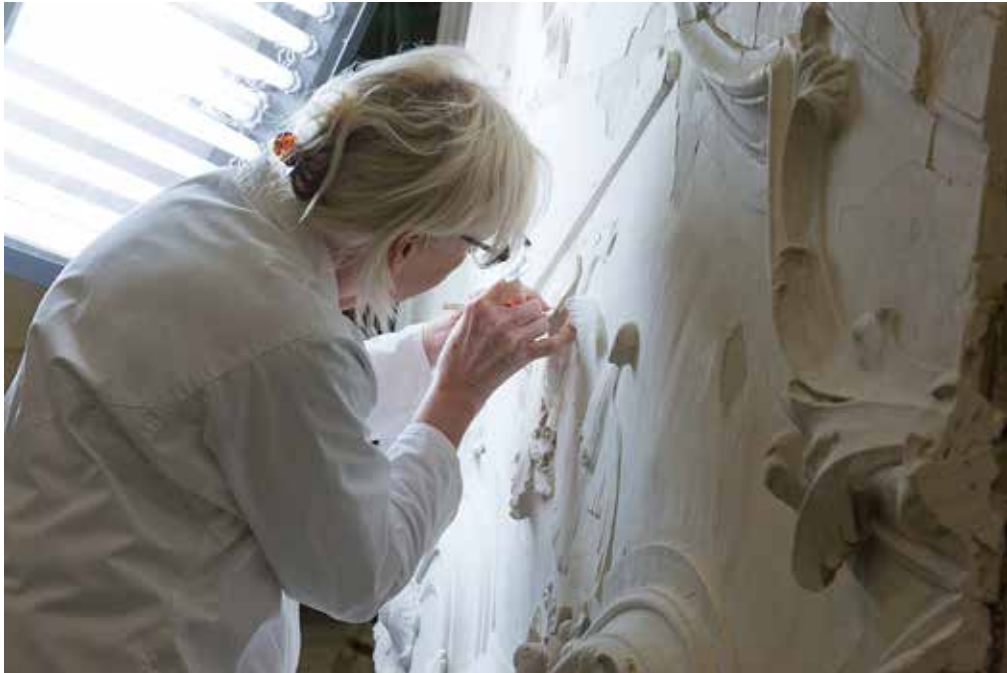
Fig. 12
Marie Huys using a scalpel to remove later coats of whitewash from the original plasterwork. Photo: Amsterdam, Rijksmuseum, HA-0022610.

Restoring and conserving the paneling and the ceiling was done as far as possible in the repository. As well as consolidating the wooden framework of the ceiling elements, it entailed filling cracks and gluing loose pieces, making good holes, joins and missing mouldings and cleaning all the parts. Unlike the installation in 1896, lime plaster was used to make good the ceiling. It has the same physical properties as the original plasterwork and, unlike gypsum plaster, dries gradually. Adding the finishing plaster layer was postponed until the room was installed. After dirt and deposits had been removed, the beeswax finish on the panelling proved to be well preserved. The same was true of the elements treated previously for the *Rococo* exhibition. The ceiling was found to have three to five coats of whitewash. A trial to remove it revealed so much greater sharpness of the ornaments and mouldings that a supplementary commission was given to remove the whitewash from the whole ceiling

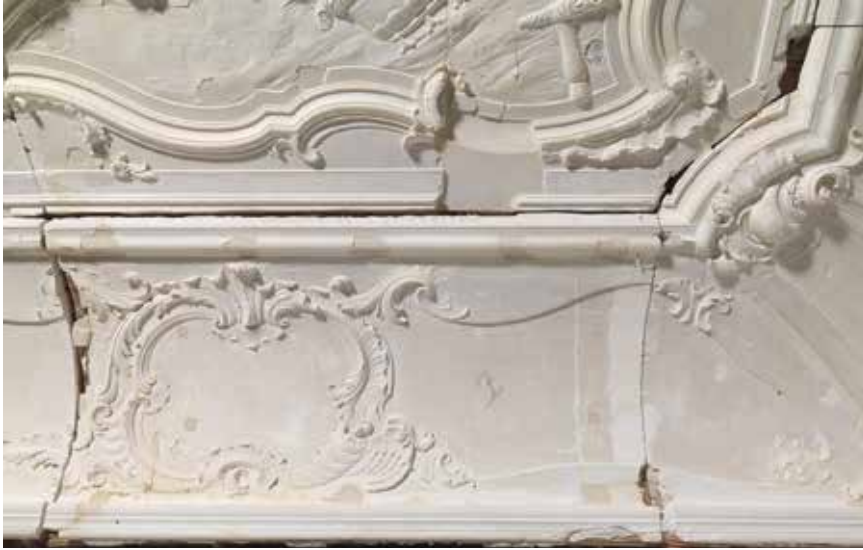
Fig. 13
Corner of the ceiling during the trial set-up in the Rijksmuseum repository. The individual ceiling elements have been consolidated, and holes or missing pieces have been filled with lime plaster. The finishing plaster layer, mouldings and ornaments were completed after the ceiling was installed. The white areas are earlier restorations with gypsum plaster.

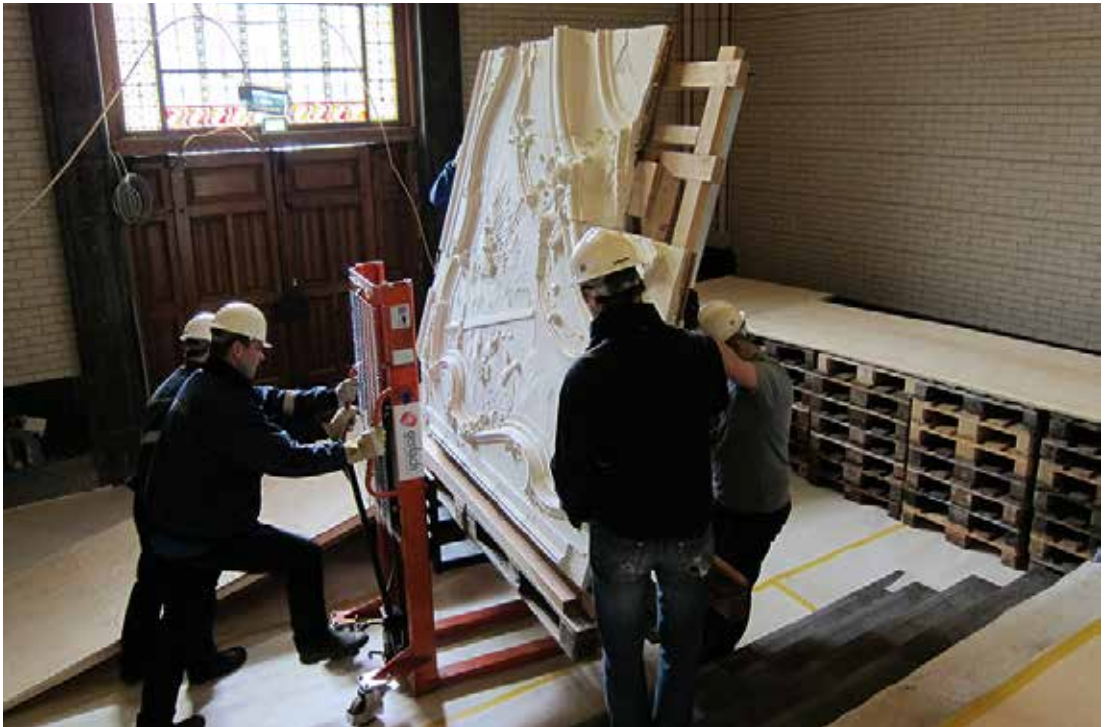
Fig. 14
Transporting the largest section of the ceiling through the Rijksmuseum's former main east entrance, 12 April 2012.

In 2012, the final transport of the Beuning and the Kops Room from the repository to the Rijksmuseum by Crown Fine Art took seven journeys by a large van with a trailer. The ceiling elements were transported virtually upright, at an angle of 75 degrees, mounted on pallets; the panelling was packed in crates and transport frames (fig. 14).

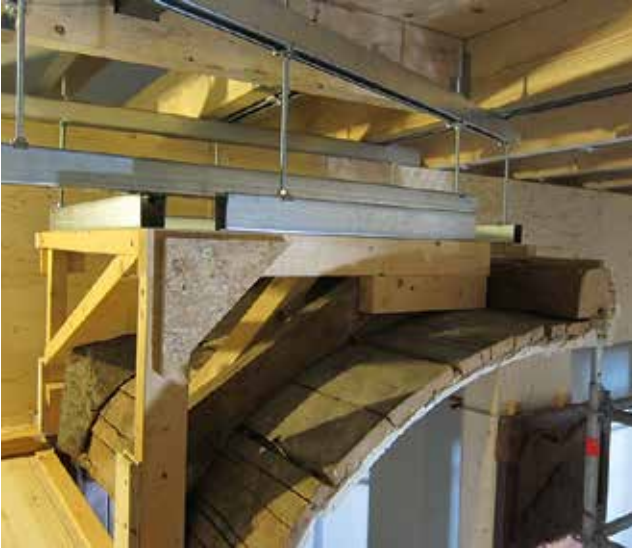
Fig. 15

Suspending a corner piece of the ceiling from the beam framework in the Rijksmuseum. Unistrut channels are attached to the ceiling and the beams.

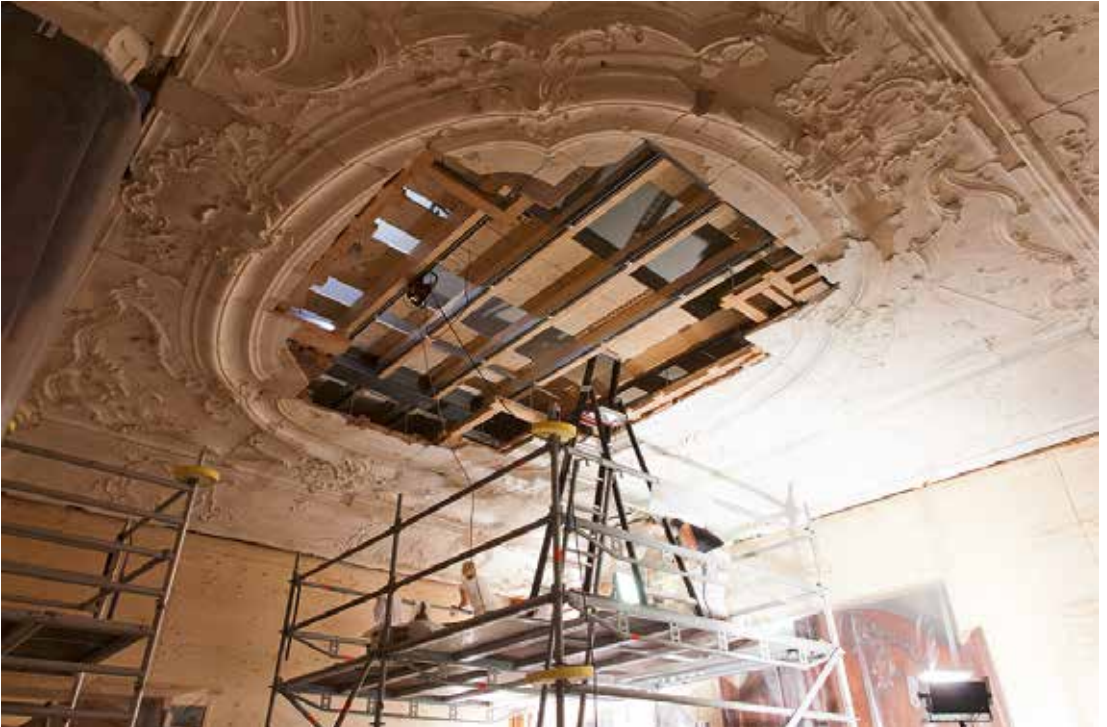
Fig. 16

The ceiling after it was suspended in the Rijksmuseum. The joins between the parts of the ceiling were filled with coarse lime plaster. The final fine plaster

layer, mouldings and ornaments still have to be completed, as does the flat oval in the centre. Photo: Amsterdam, Rijksmuseum, HA-0025561.

Once all the elements had been installed, the conservation and installation of the room could be completed. The joins between the ceiling elements and the missing flat central area were filled with a coarse lime plaster (fig. 16) and all the added elements were finished with a smooth layer of plaster. An extremely thin layer of pipeclay was applied to mask the differences in colour between the original plasterwork and

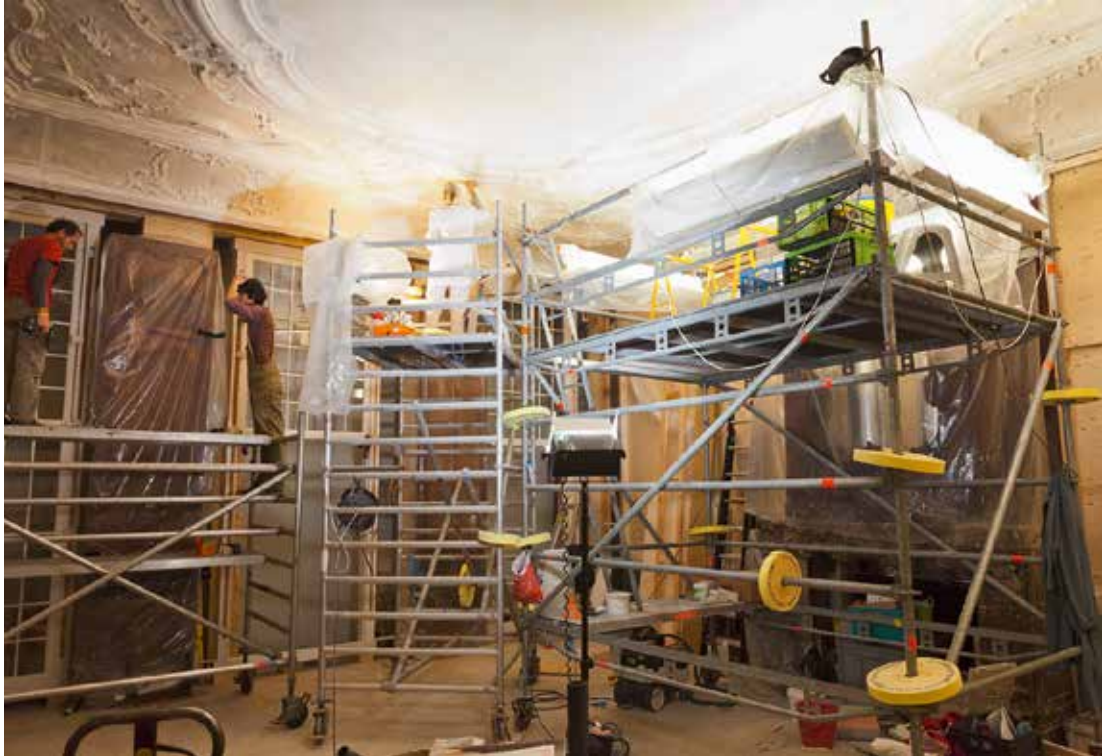
Fig. 17
Installing the new frames and making good the plaster layer as part of the installation of the room in the Rijksmuseum. Photo: Amsterdam, Rijksmuseum, HA-0029047.

the 1896 and 2012 additions. The window wall was reconstructed by Lucas de Jong to the design described above, with new frames, skirtings and other missing finishing carpentry (fig. 17). The area of the missing shutter casings either side of the pier-glass walls was filled with a neutral field, painted in a plain colour approximating mahogany. The layer of wax on the mahogany was polished up and lightly supplemented where necessary.
