# Reconstruction of the Cuypers Floor in the Entrance Hall

In 2011 the lost terrazzo floor in the Entrance Hall was reconstructed as part of the integral renovation of the Rijksmuseum (2003-13). This floor, with its marble mosaic designs, is an important element in restoring the original character of the galleries in the main axis of the museum. The Entrance Hall is the only area where the wall and ceiling decorations and the original floor finish were completely reconstructed and renovated. This article examines the questions of why and how the floor was reconstructed from the researcher's perspective. The author of this article, an architectural historian at the Bureau voor Architectuurhistorie Kariatiden, the research department of Van Hoogevest Architecten (the firm responsible for the restoration of the Rijksmuseum), was involved in the research into historic structures and finishes, including research into the Entrance Hall floor, throughout the reconstruction process.

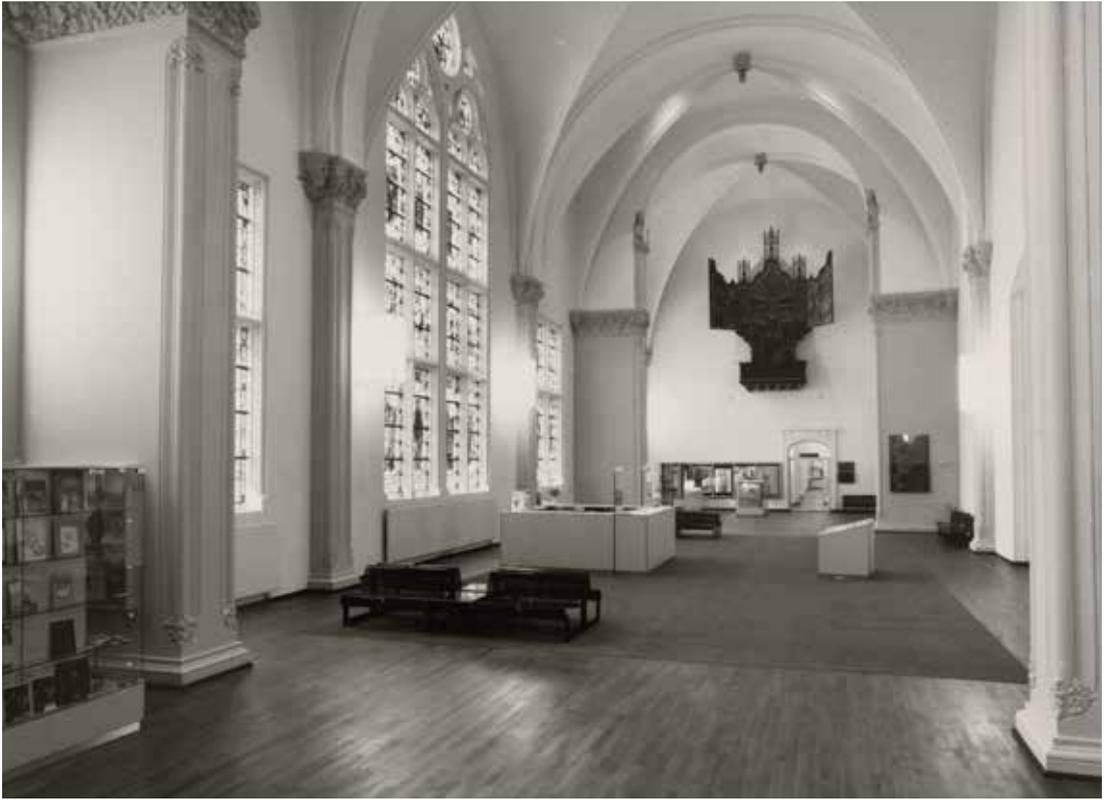
*Fig. 1*

The Entrance Hall as it was before the recent restoration, with the original decoration under a layer of white paint and the terrazzo floor replaced by a wooden floor, c. 1990.

had meant that the colourful Cuypers decorations in all the galleries had been whitewashed over to create a neutral environment for the collection (fig. 1). The reassessment of the nineteenth-century heritage consequently resulted in major changes to the space in the Rijksmuseum and to the colours in the interior. The nineteenth-century painted decorations were restored on the walls and ceilings of the main staircases, the Entrance Hall, the Gallery of Honour and the Night Watch Gallery. In terms of the colour scheme, the original decorations support and reinforce Cuypers' architectural concept, which can now be seen and appreciated in the main axis of the museum.

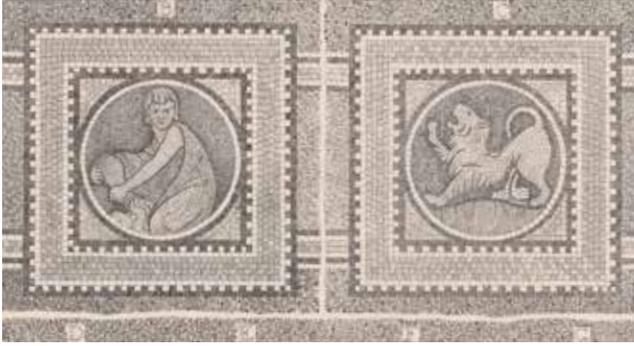
Fig. 3  
Cuyper's design for  
Leo and Aquarius.  
Rotterdam, NAI,  
RYKS, inv. no. t2246.

Cuyper's own sketches for the floor<sup>10</sup> and two detailed drawings of the Aquarius and Leo star signs (fig. 3),<sup>11</sup> published in Cuyper's book on the Rijksmuseum,<sup>12</sup> gave a good idea of the layout, execution and detail. In tandem with the literature research,<sup>13</sup> the design drawings were studied in the Cuyper archives, which are in the Netherlands Architecture Institute (NAi) in Rotterdam. Beautifully coloured floor drawings gave a clear picture of the patterns and colours of the floors in the other museum areas, but a drawing of the floor in the Entrance Hall was not found at that time. The historical floor specifications, however, are available.<sup>14</sup> They revealed that the floor was made by 'Mosaik-Terrazzo-Boden-Fabrikant' Johann Odorico in Frankfurt am Main, a large, well-established company with hundreds of employees from the Italian region of Friuli, north of Venice. The contract was awarded in Haarlem in September 1881, but the work was still not finished at the opening on 13 July 1885.<sup>15</sup> The specifications included other stipulations with regard to the making of 'sprinkled' terrazzo bands with figures in marble mosaic. A size of 1.5 centimetres was prescribed for the square marble stones, which were to be supplied in various colours. However Cuyper's drawings of Aquarius and Leo indicate a variation in the size of the stones. This created shadows and gave the figures depth. Further research in the Rijksmuseum's image bank unearthed a clear photograph (fig. 4) of the space before furniture was placed in it. Zooming in, we can see the figures described in the literature. The photograph is clear

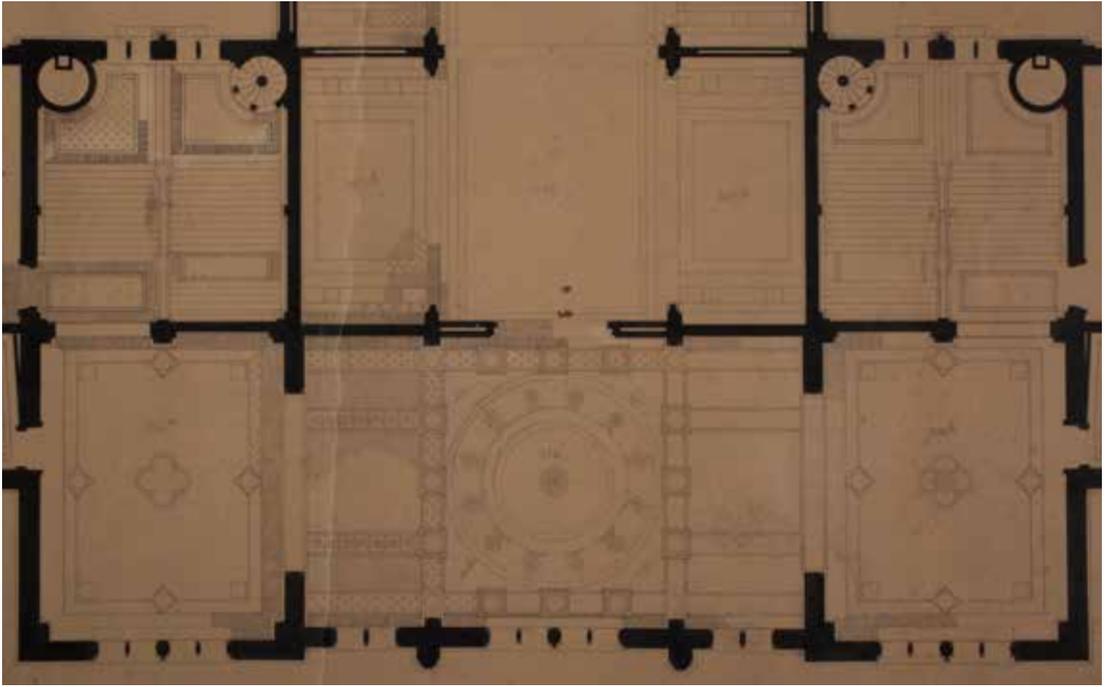
Fig. 4  
The Entrance Hall  
with the original  
terrazzo floor, c. 1909.

proof that this floor programme including the figures was actually implemented.

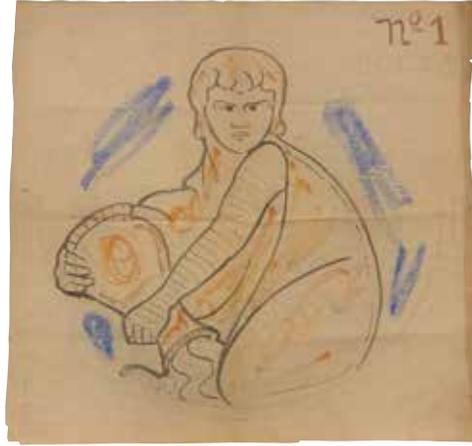
Fig. 6  
Sketch of Aquarius.  
Rotterdam, NAI,  
cuco, inv. no. t737.  
Photo: author.

A further important discovery was an actual-size sketch for the Aquarius (fig. 6).<sup>17</sup> The drawing was found in the archives of Cuypers's studio, which had not been as extensively researched in 2002 as it has now. Improved access

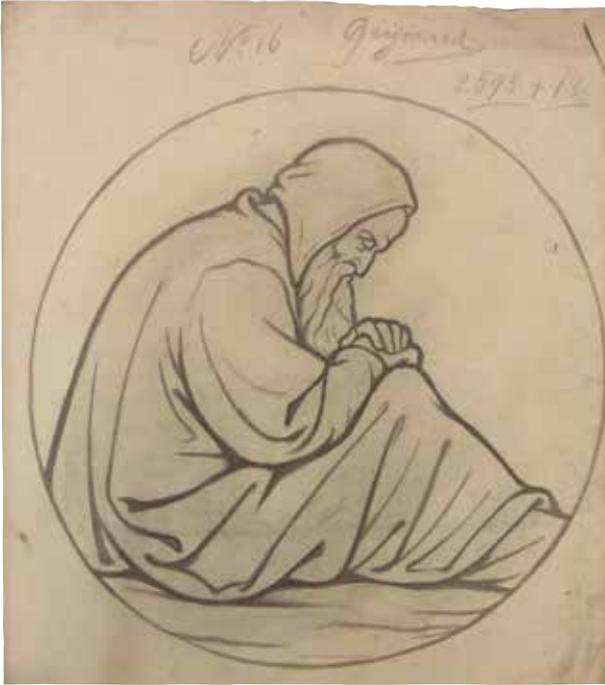
*Fig. 7*  
Sketch of the  
old man.  
Rotterdam, NAI.  
Photo: author.

parts of which were carried out in Italy. The stones were sketched in on a number of drawings to give as good as possible an idea of the nineteenth-century concept (figs. 7-10), as Cuypers had also done in his working drawings for Leo and Aquarius. The new mosaic figures were not allowed to be too perfect – a not inconceivable risk as the figures were being made beforehand in the efficient surroundings of the Italian workshop. This differed radically from the conditions in which Odorico had had to do its work on the building site. We chose the colours of the marble in Lenarduzzi's workshop (fig. 11) because a trial piece sent from Italy was not immediately convincing.

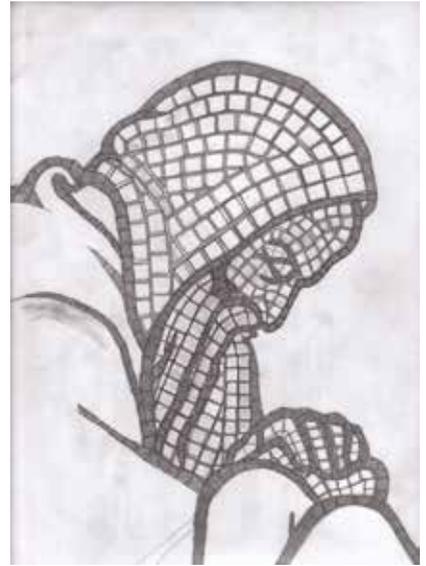
*Fig. 8*  
The author's drawing  
of the old man for  
the Italian workshop.

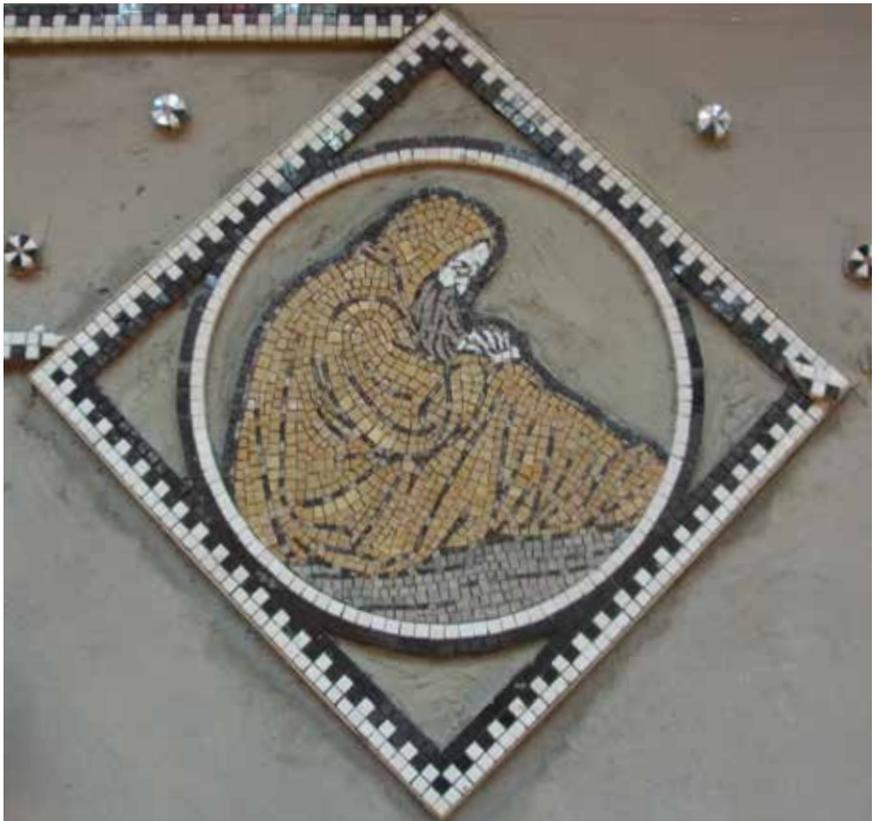
*Fig. 9*  
The old man laid  
out in mosaic in  
the Entrance Hall.  
Photo: author.

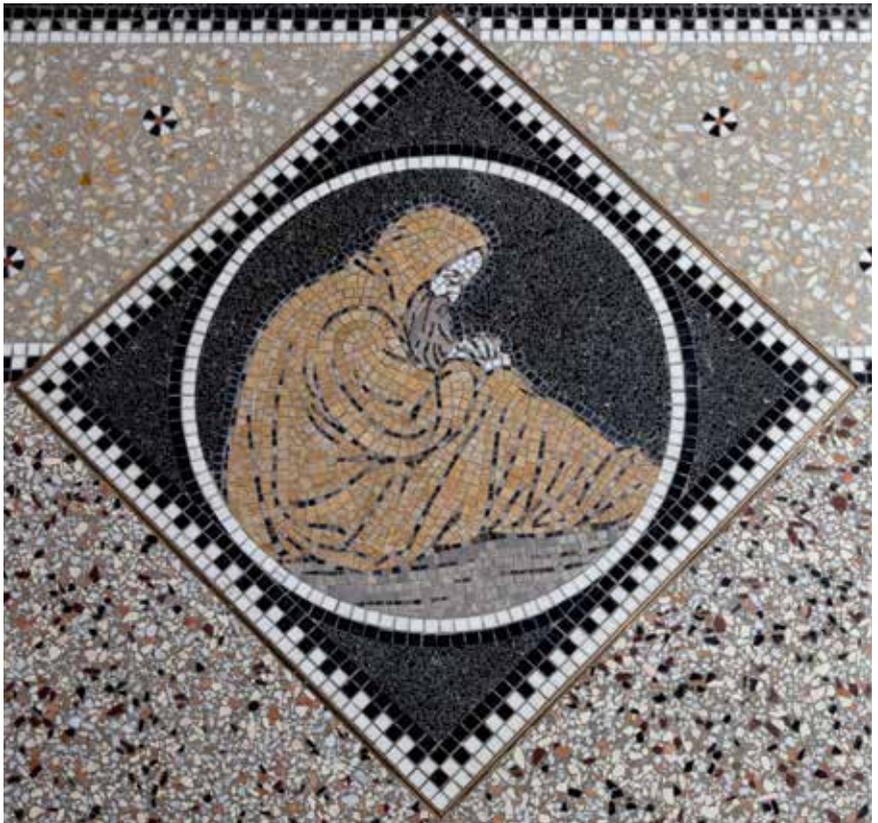
*Fig. 10*  
The old man in  
mosaic and terrazzo.

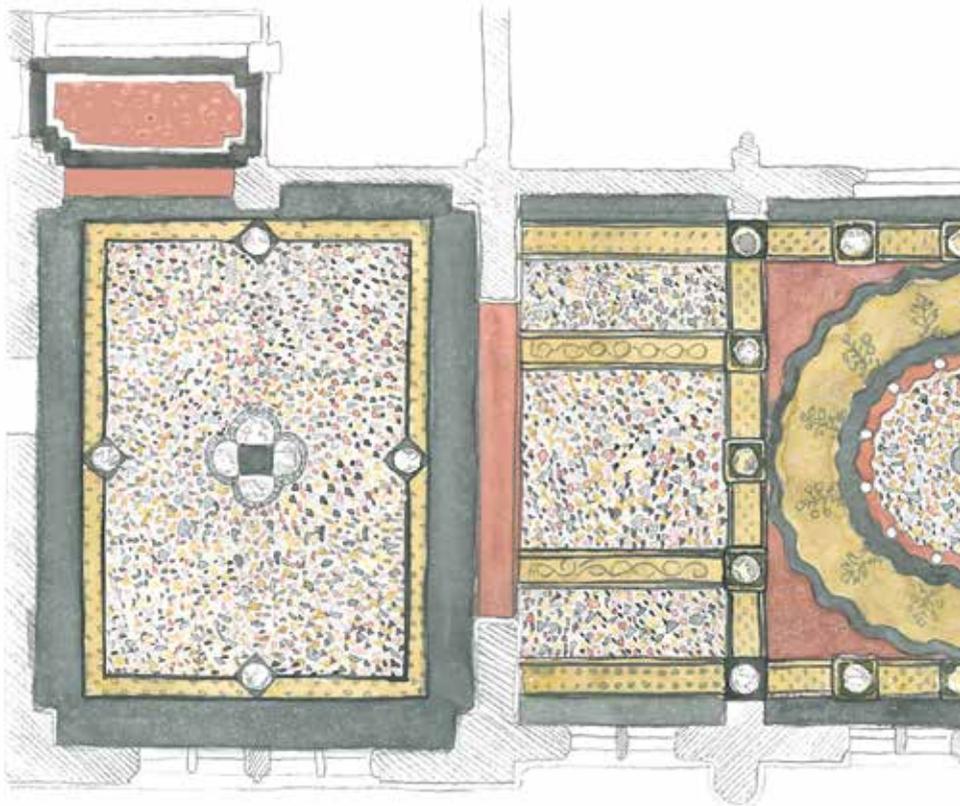
*Fig. 12*  
Watercolour by  
the author showing  
types of terrazzo  
for Candido.

were executed as 'yellow figures with black outlines on a blue background and with yellow bands'.<sup>22</sup> In historical photographs the figures show as different shades of grey, with the body parts clearly standing out as white. Taking this as the basis, we opted for abstract colours with white for the body parts. The figures were made in *giallo reale* (yellow marble) and other types of marble, which can also be found in the terrazzo floor sections. This use of colour created a good connection between mosaic and terrazzo. The choice of terrazzo was based on preserved terrazzo floors in the museum, among them the floor in the library and the terrazzo on the landings of the main staircase (fig. 12).

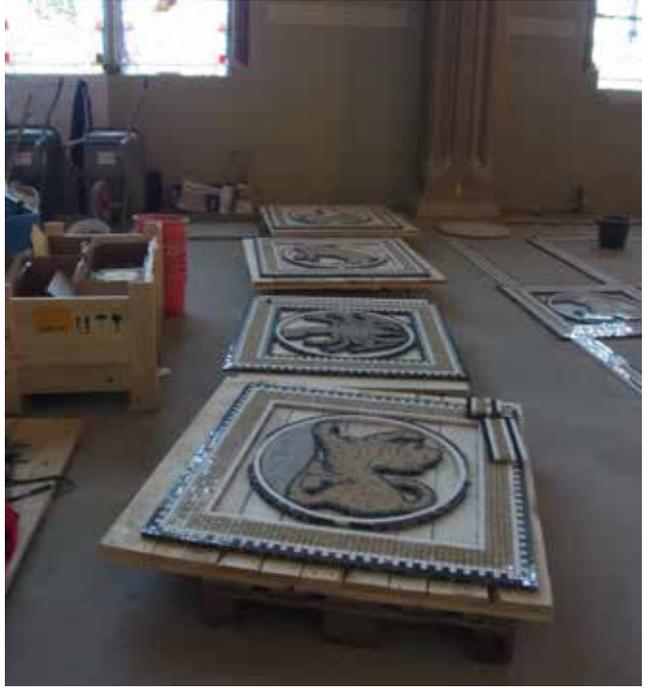
Fig. 13  
Mosaics delivered  
on pallets.  
Photo: author.

When the first pallets of mosaic arrived at the Rijksmuseum from Italy in April 2011 (fig. 13), all the pieces were laid out like a jigsaw puzzle

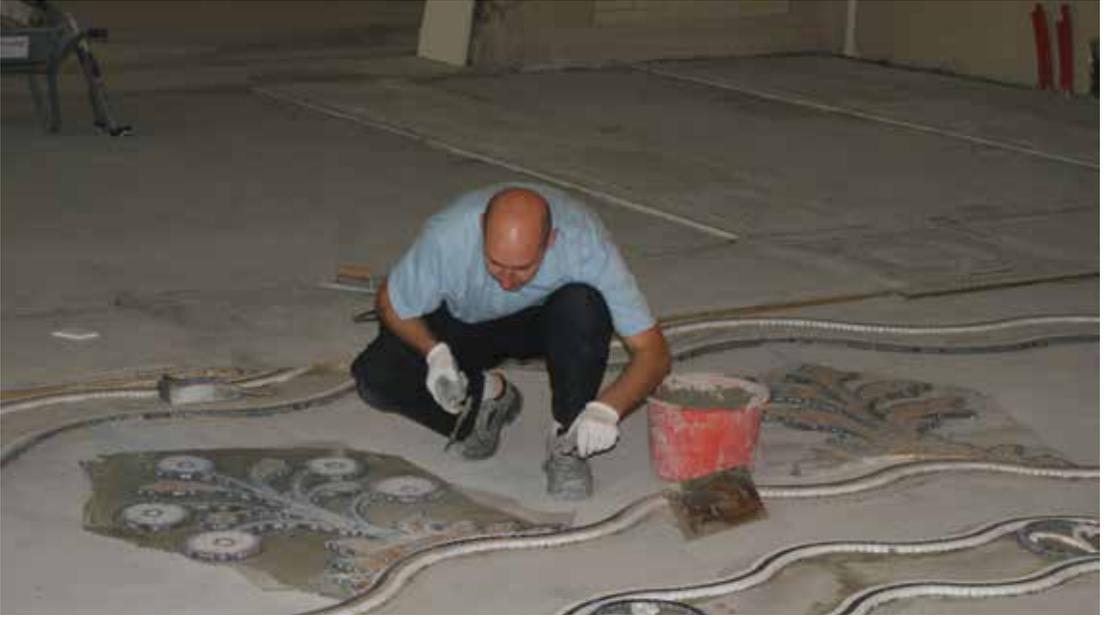
*Fig. 15*  
The central area  
laid out in mosaic.  
Photo: author.

(figs. 14 and 15). They were then grouted with terrazzo, a muddy mixture that concealed the colours of the marble chippings for a long time (fig. 16). A process of intensive sanding gradually revealed the colours and now the floor

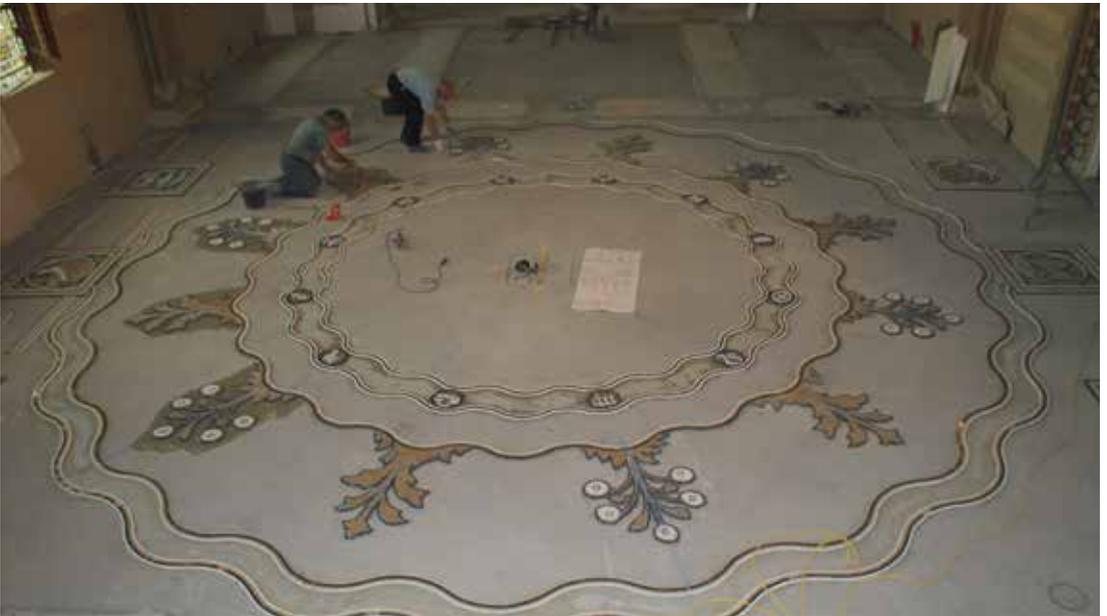
Fig. 16  
Spreading the  
terrazzo mixture.  
Photo: author.

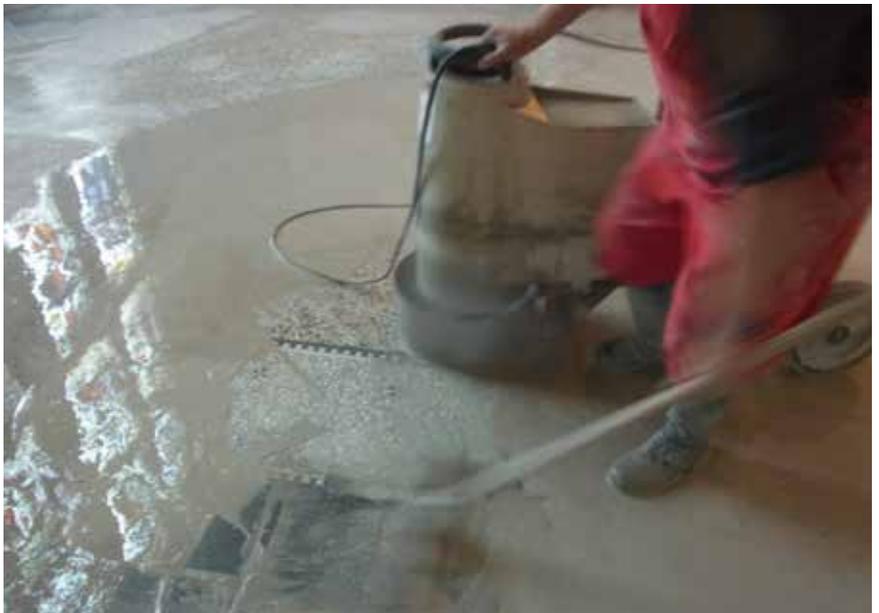
Fig. 17  
Sanding the terrazzo.  
Photo: author.

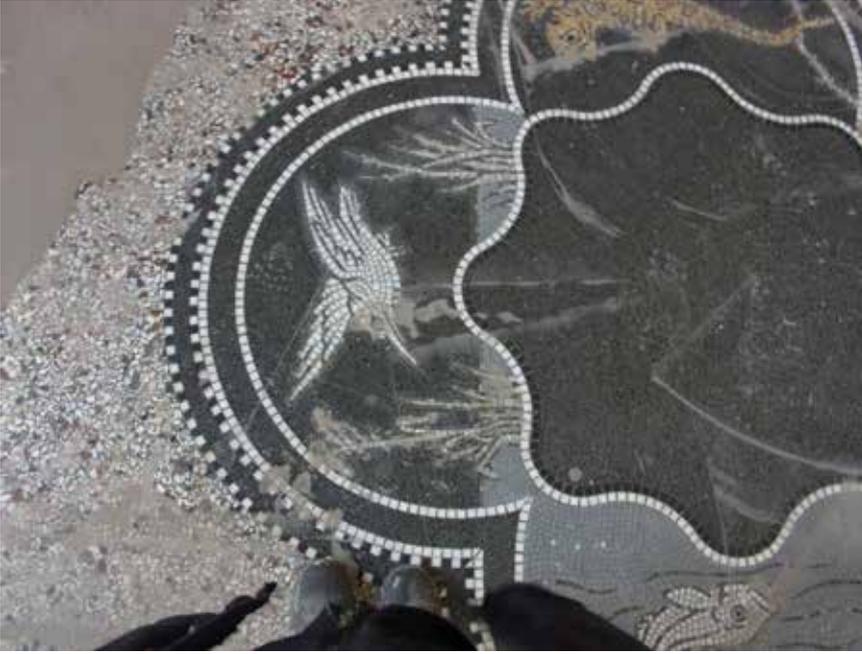
*Fig. 18*  
The western side  
zone appears.  
Photo: author.

beautifully complements the wall paintings and the stained-glass windows (figs. 17-19). The terrazzo floor with its many mosaic figures completed the iconographic programme in this important museum space. Part of
