L. Kuiper en W. Hesterman

Restauratieverslag van Rembrandts Nachtwacht

Report on the Restoration of Rembrandt's Night Watch

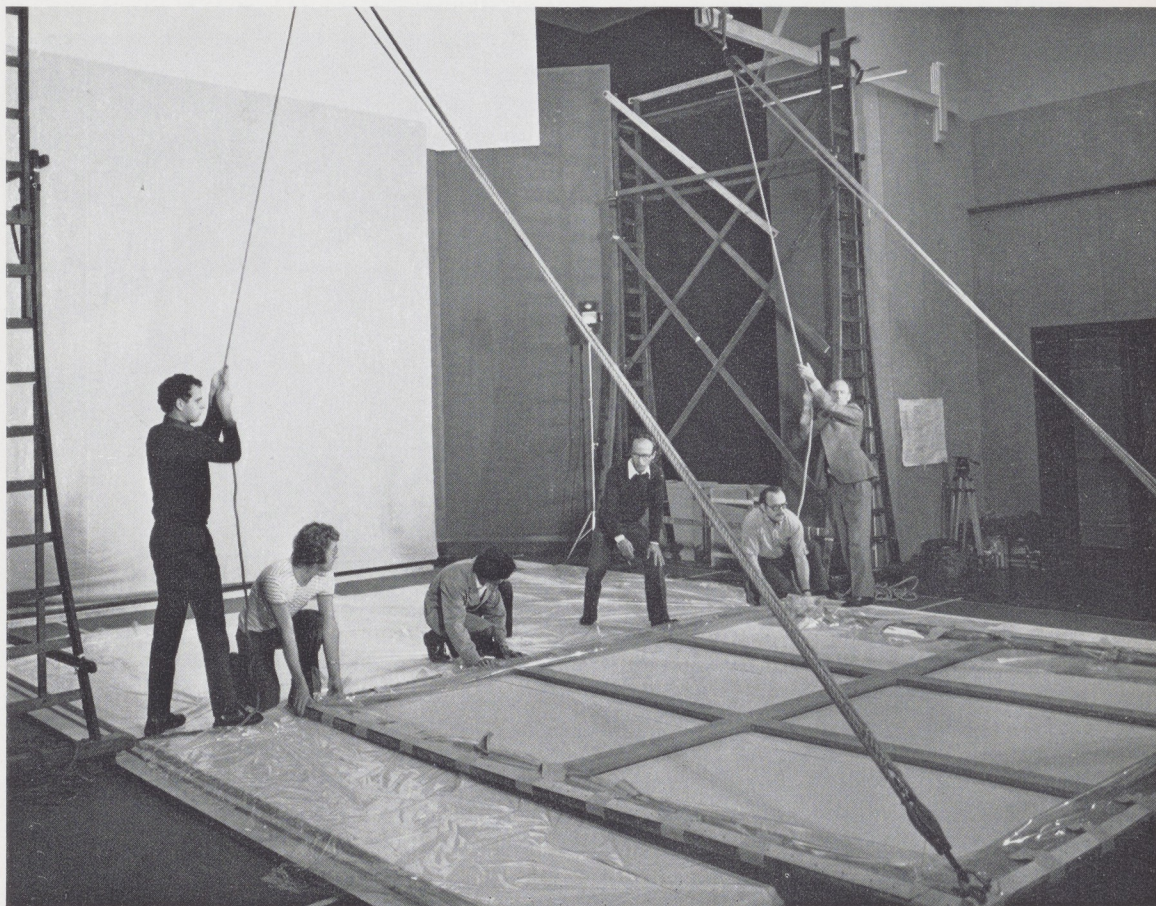
Afb. 9. Het aan het spieraam bevestigde schilderij wordt omgekeerd.

Fig. 9. The painting, back on the stretcher, being turned over.

that was later to be applied to the areas of damage would not be able to stick to the work floor. Panels of softboard were fixed to the stretcher to give support to the canvas and the stretcher was then placed on the painting, which was fastened to it by means of the tacking edges of the old relining canvas. So that the canvas would also be supported from below, bands of webbing were passed underneath the painting, which had to be lifted up a little for the purpose. The painting was then turned over without any difficulty by means of hoisting apparatus (Fig. 9).

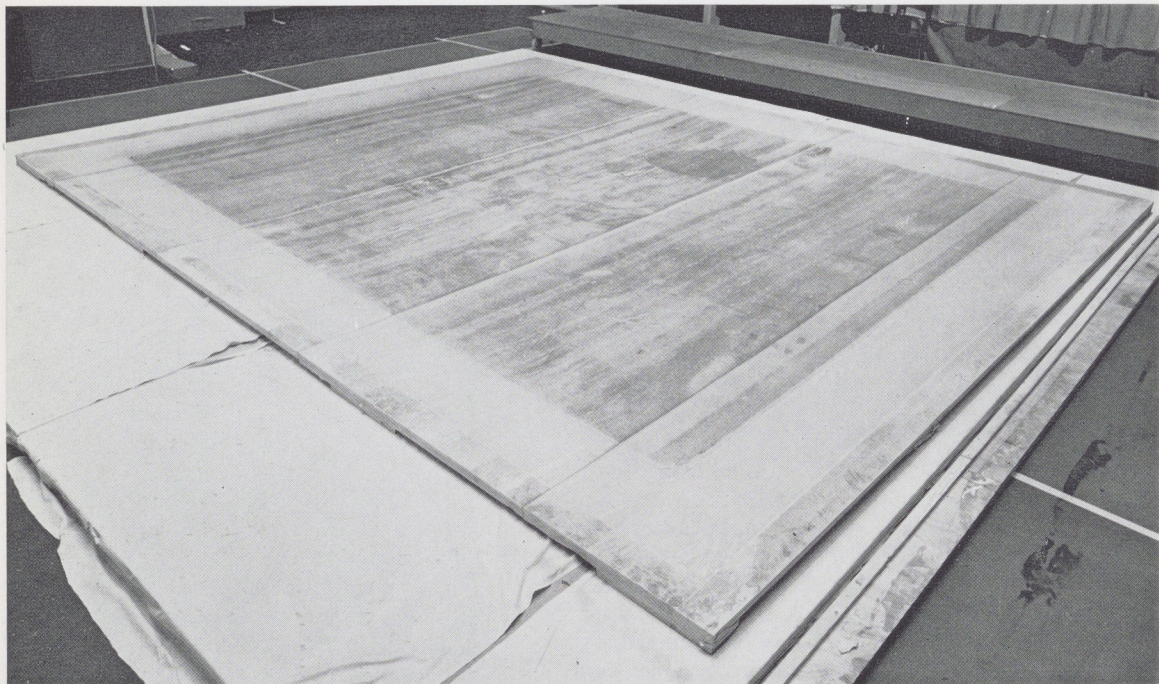
Afb. 14. Het met papierbanen in het plakraam gespannen schilderij.

Fig. 14. The painting fastened to the loom with bands of paper for relining.

paste was applied to these ends, which served as grips whereby the wet paper could be held and lifted without it tearing. After the first band, which was 140 cm wide, had been pasted, it was carried by two men to the painting on which it was stuck down in the exact centre from top to bottom. It was then taken over and stuck to the loom and the dry ends were afterwards cut off. The second and third bands were applied to the right and left of the first with narrow overlaps. Two more bands were needed for the sides of the painting and these were applied with somewhat wider overlaps over the second and third bands. The application of the five bands of paper was carried out by seven people and took 40 minutes (Fig. 14).

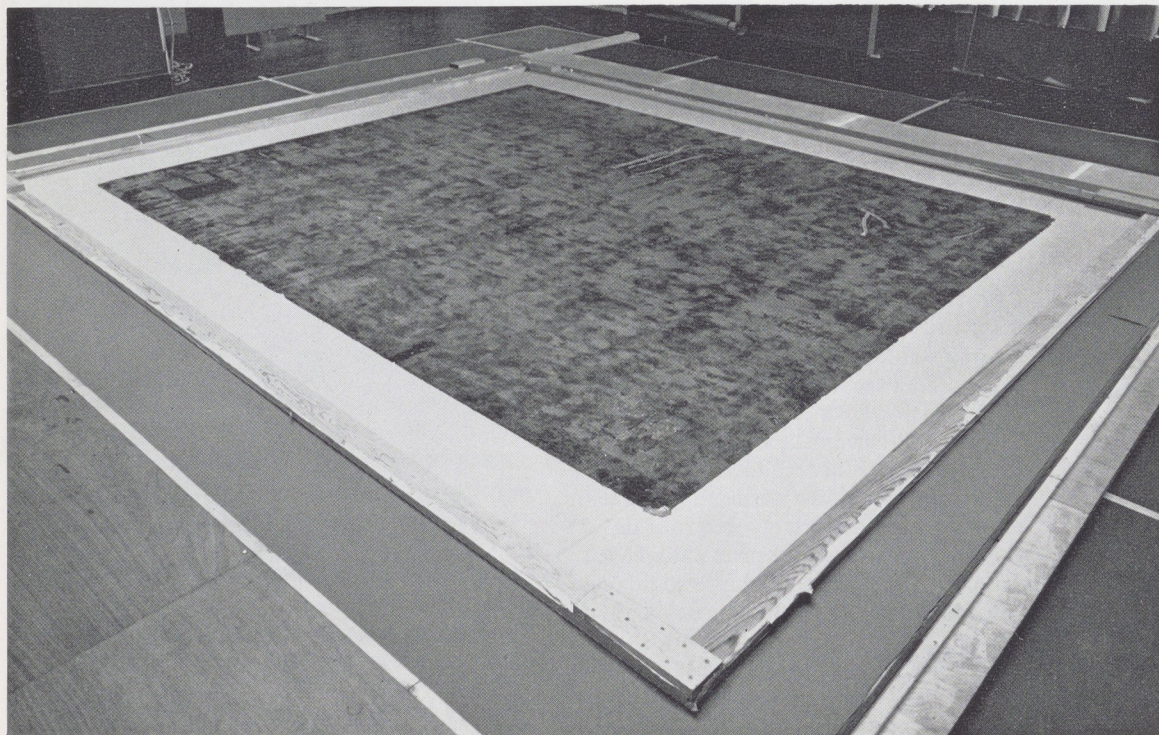
Afb. 15. Toestand van afb. 14, nadat het schilderij is omgekeerd.

Fig. 15. As Fig. 14, the painting having been turned over.

When everything was completely dry, the painting was lifted up about 80 cm and with the wooden loom placed on trestles, so that the stretcher could be removed from underneath it. The painting was then put back on the work floor again and three bands of canvas 120 cm wide were spread loosely over it. A supporting lath was applied to the centre of the wooden loom at the back of the painting in order to prevent the canvas from sagging while it was being turned over and the tension on the edges of the paper becoming too great so that they would tear. This time the painting could not be turned over by the hoist, so it was done manually. In the meantime the felt and Melinex cover of the work floor had been replaced by cork linoleum in order to obtain a springy base (Fig. 15).

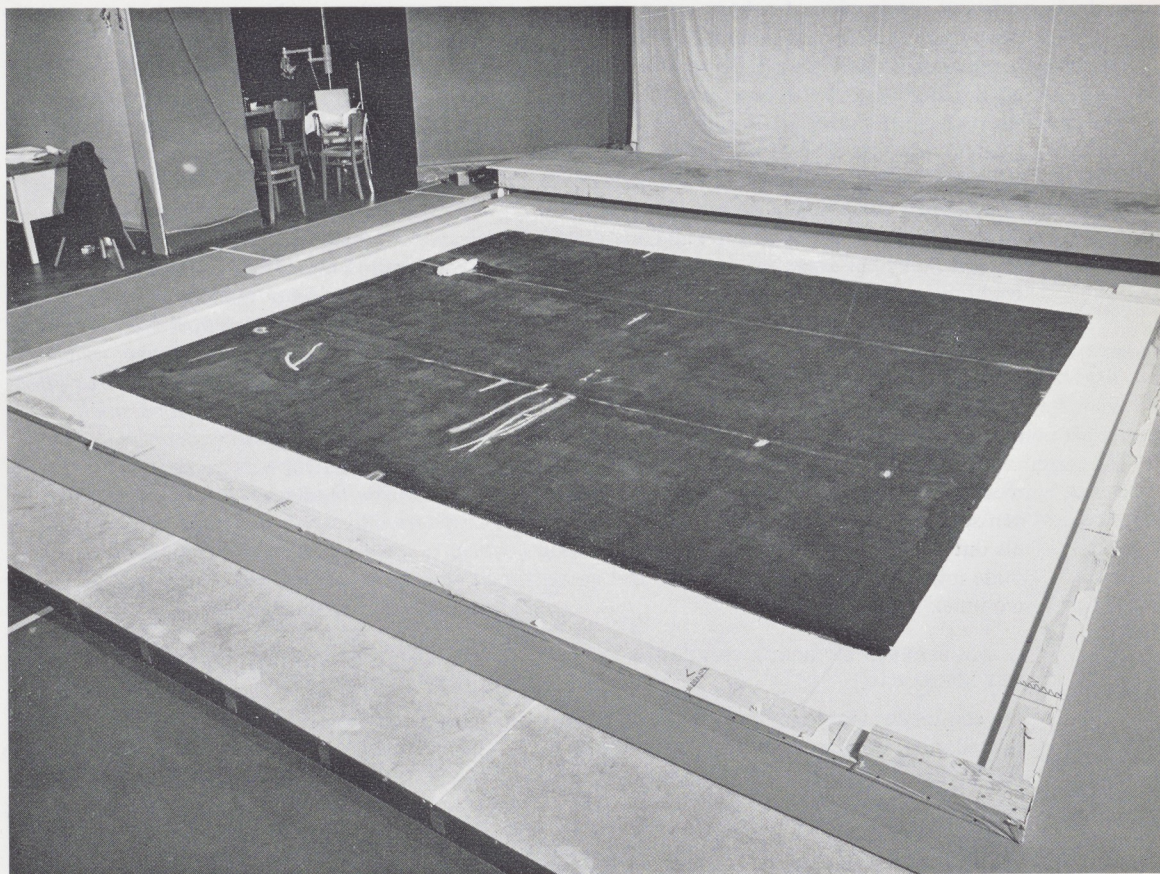
Afb. 17. Het gerepareerde doek gereed voor doubling. De naden van het uit drie stukken samengestelde originele doek zijn duidelijk zichtbaar.

Fig. 17. The mended canvas ready for relining. The seams of the original canvas, which is composed of three pieces, are clearly visible.

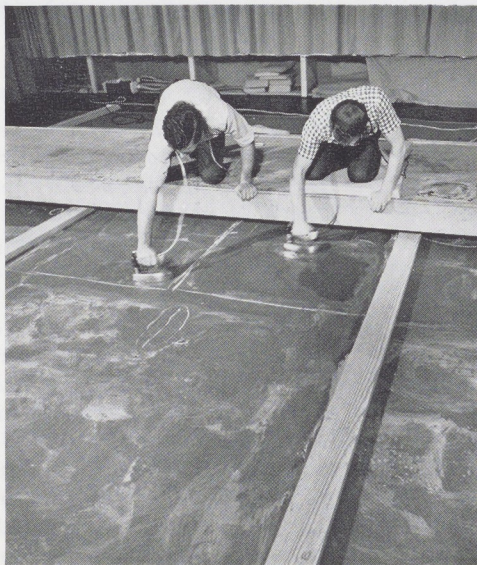
Na het strijken werd het verdoekte schilderij losgesneden van het plakraam. Het zat nu alleen nog op het spanraam. Het spanraam werd gedraaid, zodat de met papier beplakte voorkant van het schilderij weer boven kwam te liggen. Het papier werd er droog afgetrokken. De totaal gecrepeerde vernis was wit uitgeslagen door het water in de lijm (afb. 19).

The ironing, done by two men using irons of medium weight, took three hours (Fig. 18). Some air bubbles formed near Banning Cocq's head, but these were laid down by further ironing with a cold iron.

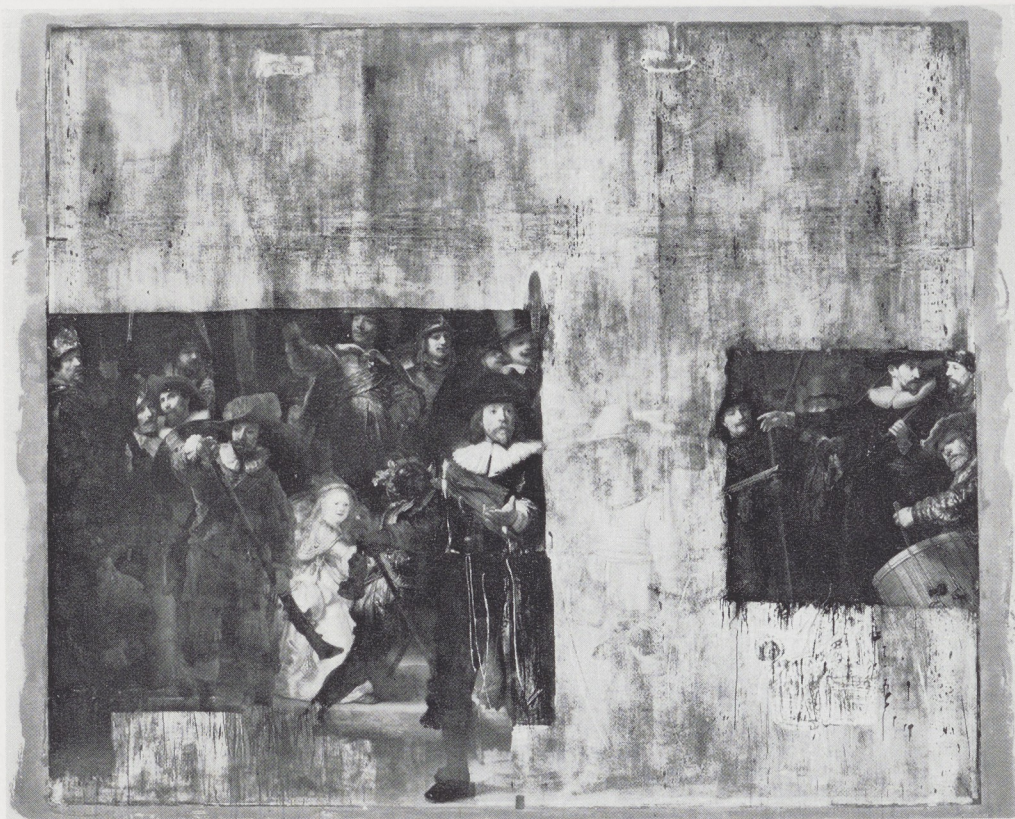
Afb. 20. Het schilderij tijdens de verwijdering van de vernis.

Fig. 20. The painting during the removal of the varnish.

In general the paint layer appeared to be in sound condition. In the dark topmost parts of the painting in particular the lively brushwork had become very clearly visible again. Some bare and abraded patches did, however, come to light, but these were already known to exist. The surface of the paint in the area of

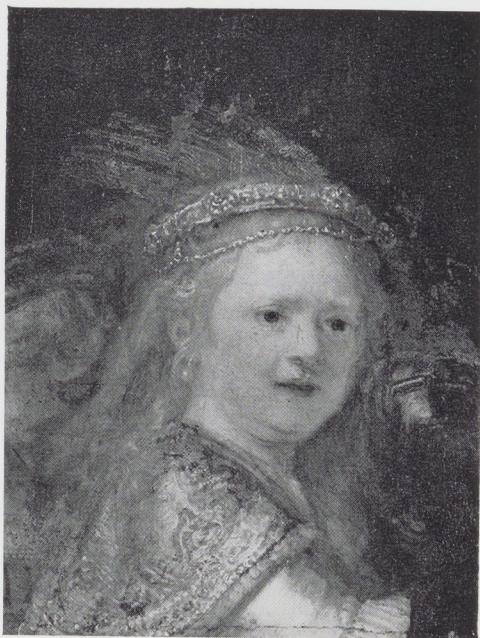
Afb. 25. De plaats van afb. 24 na het aanbrengen van retouches.

Fig. 24. The obtrusive area above the head of the girl with the chicken after the removal of the old varnish.

Fig. 25. The area in Fig. 24 after retouching.

degree of clarity and, finally, on the so-called headdress just above the head of the girl with the chicken (Figs. 24 and 25), which can be regarded partly as underpainting and partly as a pentimento. The grey paint in this last place, which is also to be found round Van Ruytenburch's head, is in all probability the remains of powder-smoke painted by Rembrandt.

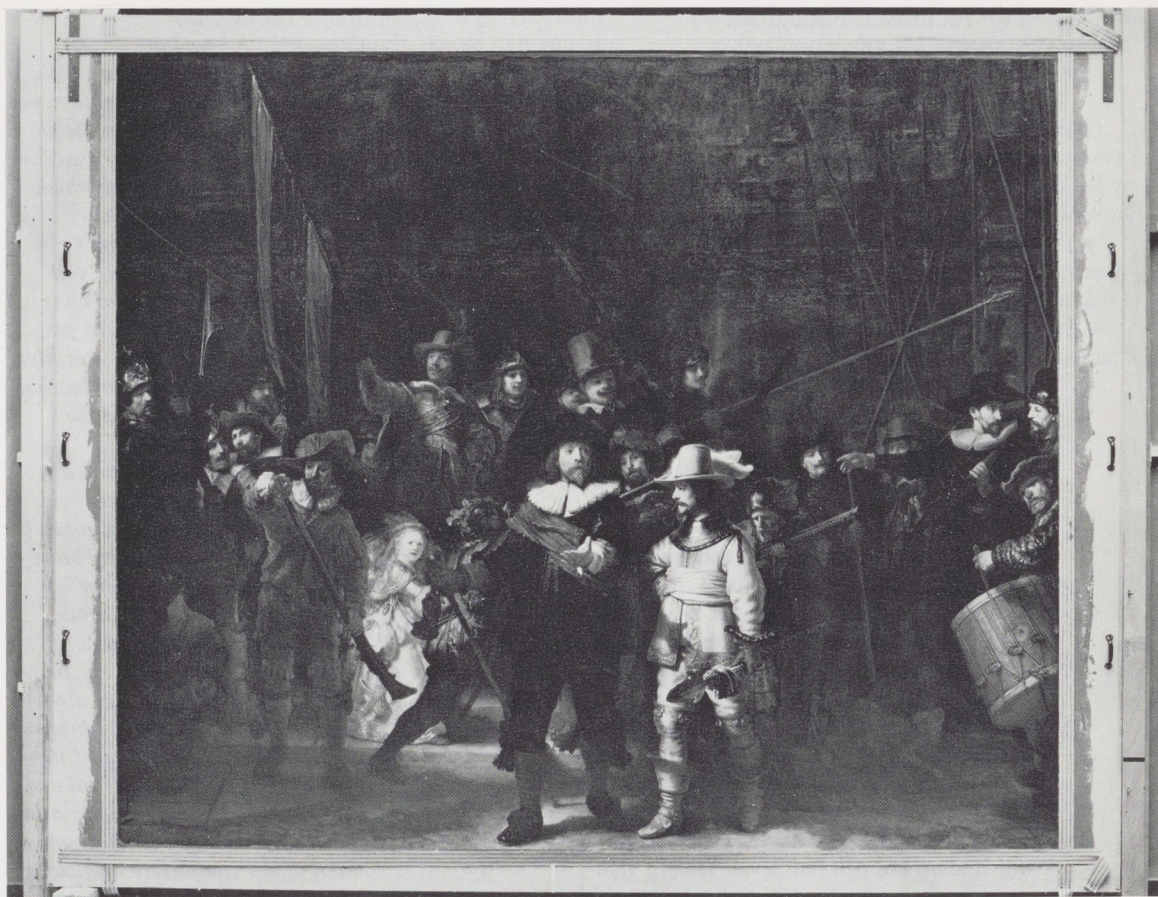
Afb. 26. Het in de juiste stand geplaatste schilderij binnen de met singels aangegeven rechthoek.

Fig. 26. The painting in its correct position within the rectangle indicated by bands of webbing.

First of all the correct position of the painting was determined from the horizontal lines of the step and the architecture in the background. Then four bands of webbing were placed around it to form an exact rectangle (Fig. 26) and the narrow wedge-shaped strips between the webbing and the painting, which measured about 2 cm at their widest points, were painted in.
